MERCEDES A: 1EYF750

Limited Technical Inspection

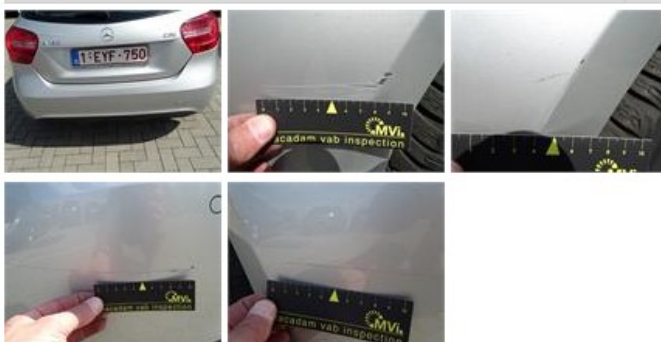
| Bumper R, Scratch(es), LI - Repair and paint (complete) | 211,80 |
