FORD S Max: 1EZQ800

Limited Technical Inspection

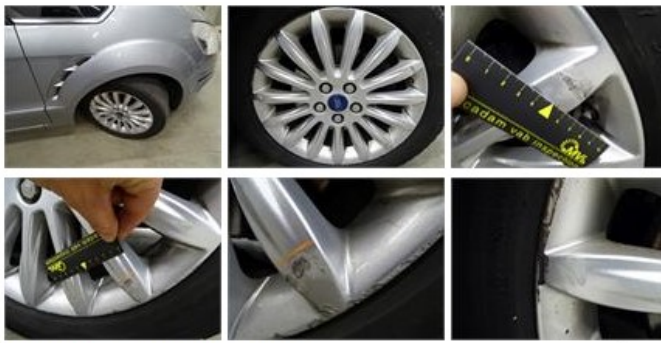
| Alloy rim F R, Scratch(es), LI - Repair and paint (complete) | 0,00 |
