<b>PEUGEOT 5008: 1ERM178</b>			
Vinnumber:	<b>VF30A9HD8DS026678</b>	Versionname:	<b>5008 Access FAP 115PK</b>
First Registrationdate:	<b>1/03/2013</b>	Fiscalpower:	
Expertise Mileage:	<b>137421</b>	Power Kw:	<b>84</b>
Bodytype:		Body color:	<b>Black</b>
Gearbox:	<b>MAN 6 VIT</b>	Paint type:	<b>Metalic</b>
Transmission:		Rims summer:	<b>Steel</b>
Fueltype:	<b>Diesel</b>	Oil level:	<b>OK</b>
Battery functioning:	<b>Yes</b>	Parking lot:	<b>2532</b>
Number of doors:	<b>5</b>		
Number of seats:	<b>5</b>		
Number head rests:	<b>5</b>		
Rims summer:	<b>Steel</b>		
Category:	<b>Passenger Car</b>		
Oil level:	<b>OK</b>		
Registration Certificate Car (BE):	<b>Yes</b>

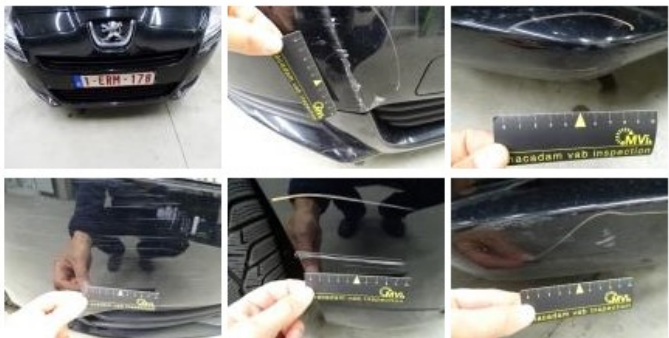
<b>Total cost ex VAT</b>	738,48
<b>Front bumper, Bump(s) and scratch(es), LI - Repair and paint (complete)</b>	211,80

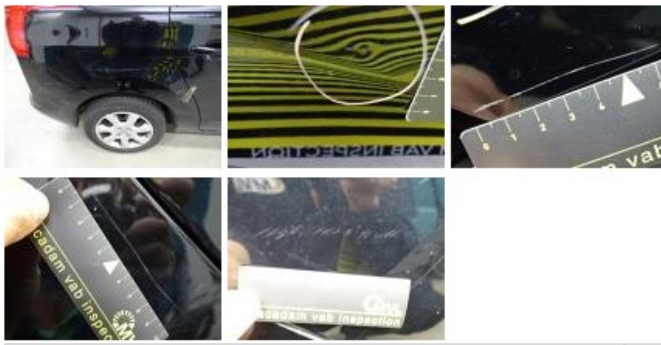
<b>Wing R R, Scratch(es), LI - Repair and paint (complete)</b>	0,00
--	------

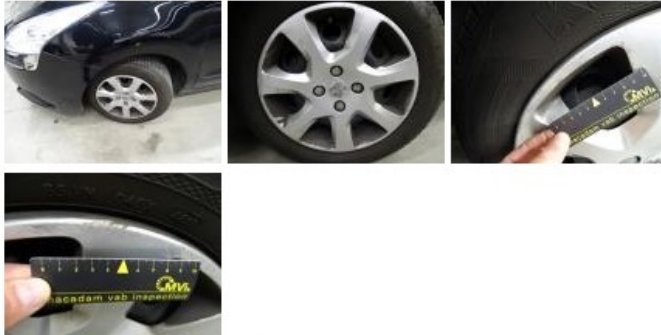
Wheel cover F L, Scratch(es), E - Replace 30,00

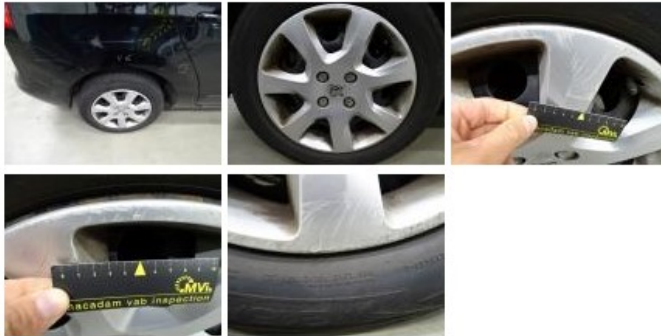
Wheel cover R R, Scratch(es), E - Replace 30,00

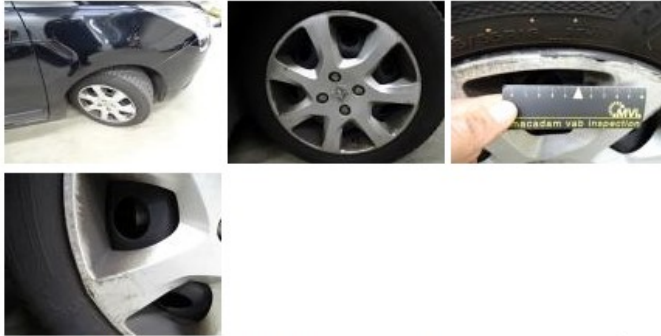
Wheel cover F R, Scratch(es), E - Replace 30,00

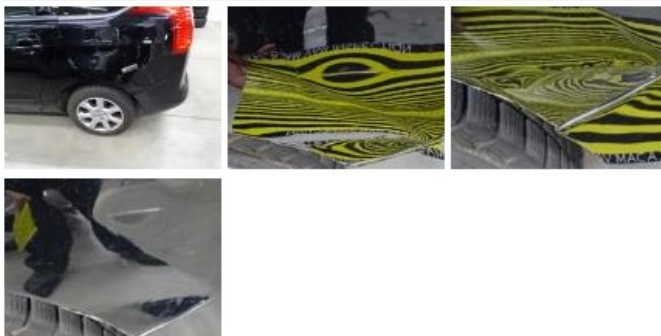
Wing R L, Bump(s) and scratch(es), LI - Repair and paint (complete) 0,00

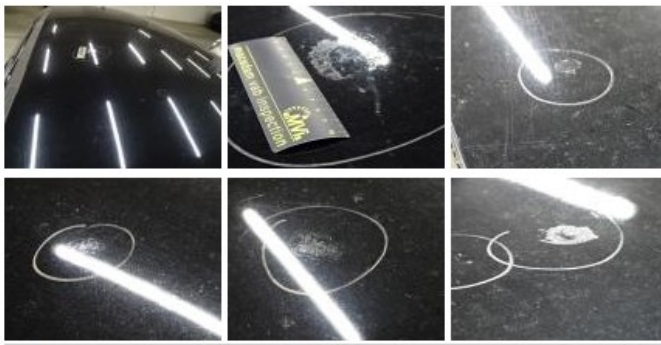
Roof, Chemical pollution, LI - Repair and paint (complete) 0,00

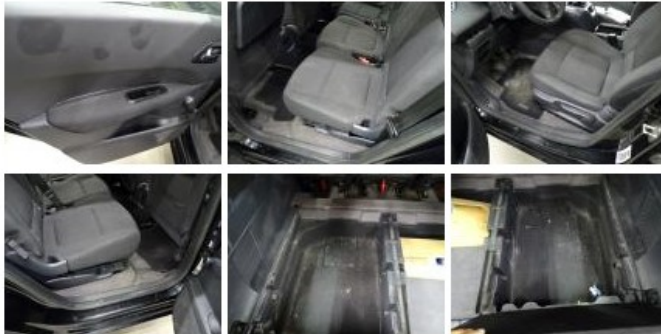
Interior, Dirty, Cleaning 25,00

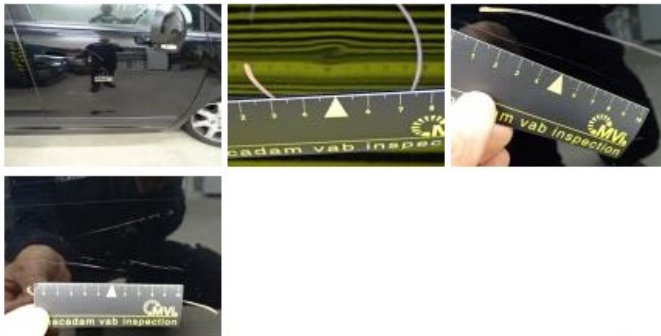
Door F R, Bump(s) and scratch(es), LI - Repair and paint (complete) 0,00

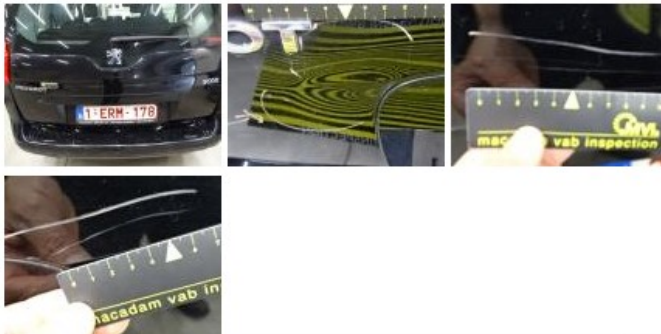
Tailgate, Bump(s) and scratch(es), LI - Repair and paint (complete) 0,00
