## SKODA Octavia: 1EVN526

## Limited Technical Inspection

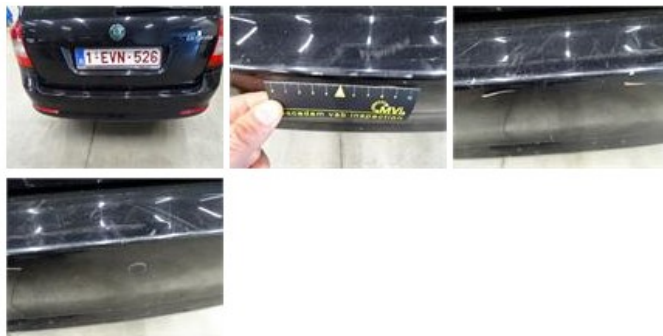
Bumper R, Scratch(es), LI - Repair and paint (complete)	211,80
---	--------
