VOLKSWAGEN Golf: 1HUP159

Limited Technical Inspection

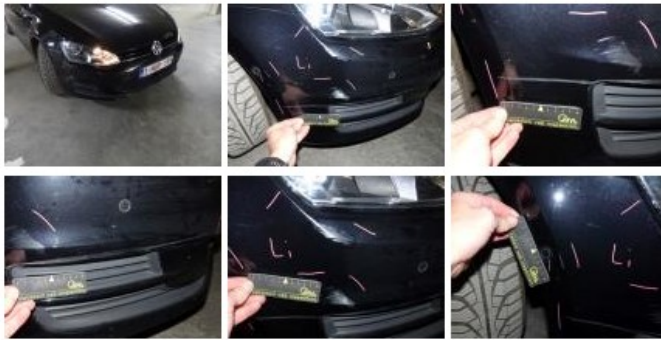
Front bumper, Damaged, LI - Repair and paint (complete) 217,44
