VOLVO V70: 1C SI888			
Vinnnumber:	<b>YV1BW88A0C1237426</b>	Versionname:	<b>V70 D3 Kinetic St/St Geartr.163PK Aut.</b>
First Registrationdate:	<b>16/12/2012</b>	Fiscalpower:	
Expertise Mileage:	<b>98064</b>	Power Kw:	<b>120</b>
Bodytype:	<b>Break</b>	Body color:	<b>Beige</b>
Gearbox:	<b>Automatic</b>	Paint type:	<b>Metalic</b>
Transmission:		Rims summer:	<b>Aluminium</b>
Fueltype:	<b>Diesel</b>	Oil level:	<b>OK</b>
Battery functioning:	<b>Yes</b>	Parking lot:	<b>1231</b>
Number of doors:	<b>5</b>		
Number of seats:	<b>5</b>		
Number head rests:	<b>5</b>		
Rims summer:	<b>Aluminium</b>		
Category:	<b>Passenger Car</b>		
Oil level:	<b>OK</b>

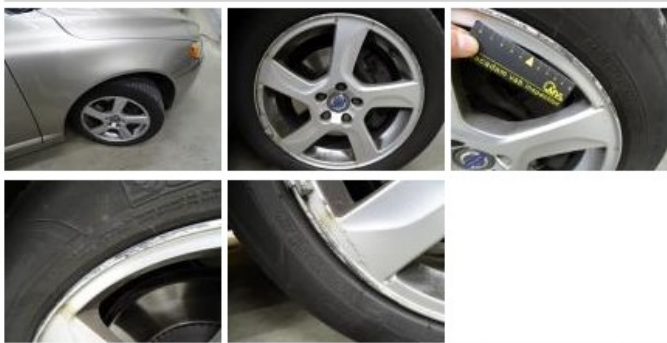
Assistance equipment			
Repair kit	<b>Yes</b>	Compressor	<b>Yes</b>
Total cost ex VAT			<b>799,80</b>
Alloy rim F R, Scratch(es), LI - Repair and paint (complete)			<b>95,00</b>

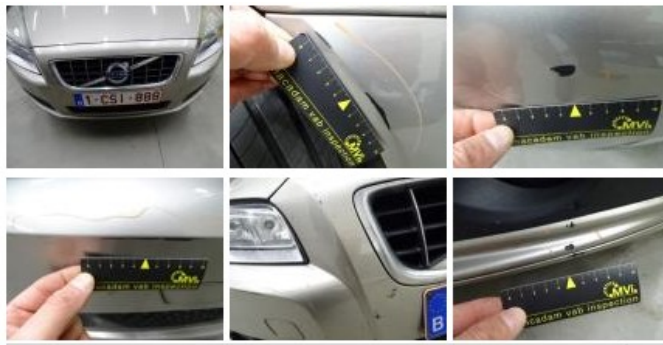
Front bumper, Scratch(es), LI - Repair and paint (complete)	<b>254,16</b>
---	---------------

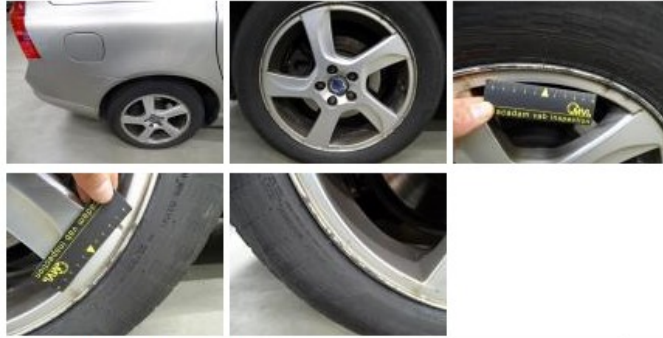
Alloy rim R R, Scratch(es), LI - Repair and paint (complete) 95,00

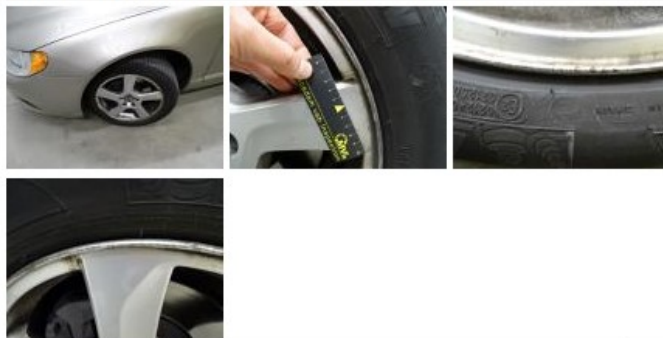
Alloy rim F L, Scratch(es), LI - Repair and paint (complete) 95,00
