| VOLVO V60: 1FTC528 | | | |
| Vinnnumber: | YV1FW31A1E1172435 | Versionname: | V60 BRE D3 Kinetic 136PK |

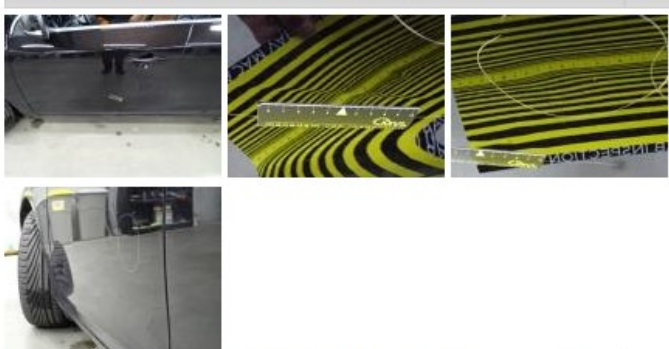
| Assistance equipment | | | |
|---|---|---|---|
| Door F L, Bump(s), LI - Repair and paint (complete) | | | 318,35 |
