| SKODA Octavia: 1EHU153 | | | |
| Vinnumber: | TMBHT21Z4D2100163 | Versionname: | OCTAVIA COMBI GTec Ambition DPF 105PK |

| Limited Technical Inspection | | | |

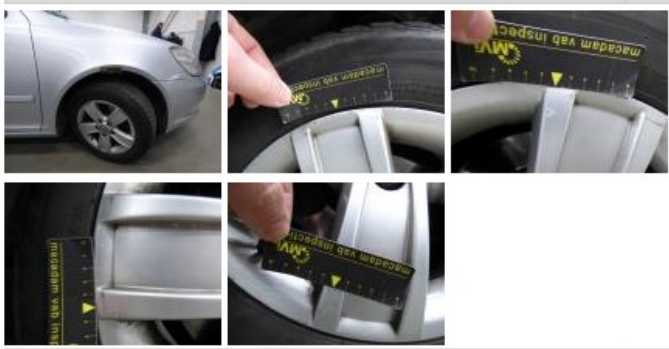
| Alloy rim F R, Scratch(es), LI - Repair and paint (complete) | | | 95,00 |
