VOLVO S40: 1CCH675			
Vinnumber:	YV1MS84F1C2569641	Versionname:	S40 BER DRiVe Start/Stop
First Registrationdate:	18/10/2011	Fiscalpower:	99g 115PK
Expertise Mileage:	120195	Power Kw:	84
Bodytype:		Body color:	Grey
Gearbox:	MAN 6 VIT	Paint type:	Metalic
Transmission:		Rims summer:	Aluminium
Fueltype:	Diesel	Oil level:	OK
Battery functioning:	Yes	Parking lot:	2202
Number of doors:	4		
Number of seats:	5		
Number head rests:	5		
Rims summer:	Aluminium		
Category:	Passenger Car		
Oil level:	OK

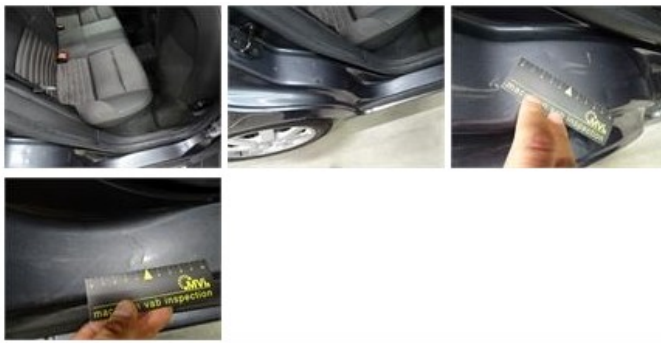
Rocker panel inner R R, Bump(s) and scratch(es), LI - Repair and paint (complete) 115,56

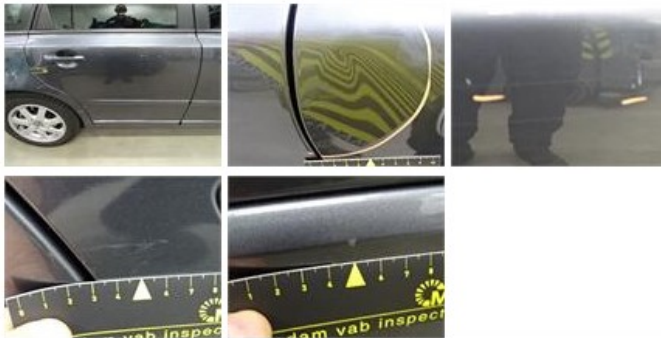
Door R R, Bump(s) and scratch(es), LI - Repair and paint (complete) 0,00

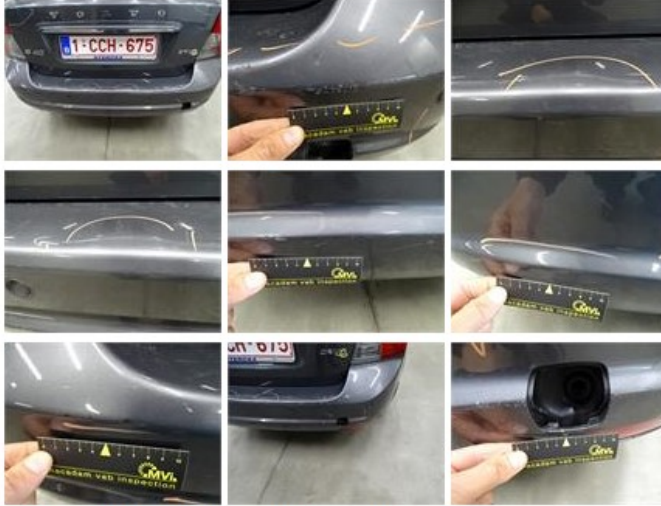
Bumper R, Bump(s) and scratch(es), LI - Repair and paint (complete) 211,80

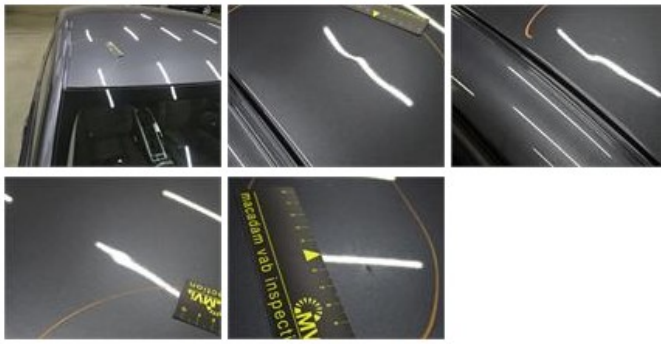
Roof, Bump(s), LI - Repair and paint (complete) 0,00
