TOYOTA AURIS TOURING SPORTS: 1NLU458

Limited Technical Inspection

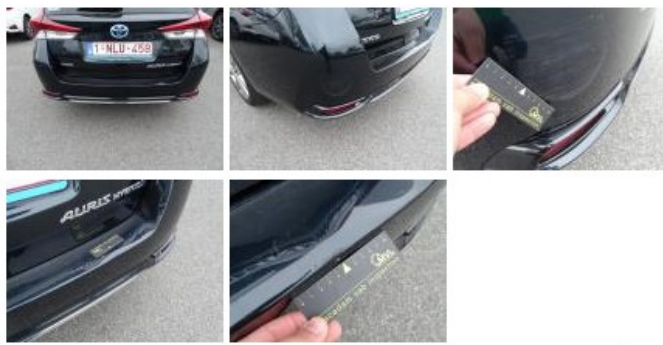
Bumper R, Bump(s) and scratch(es), LI - Repair and paint (complete)	307,80
--	---------------

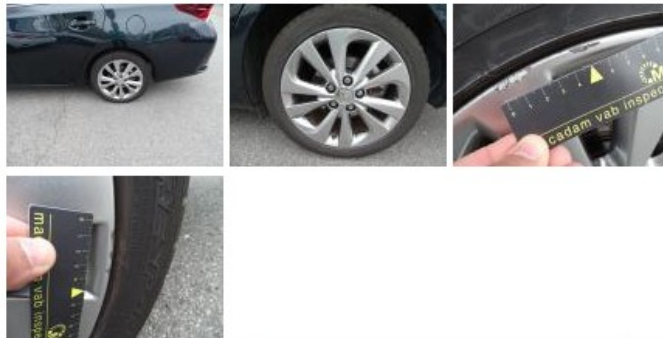
Alloy rim R L, Scratch(es), LI - Repair and paint (complete) 95,00

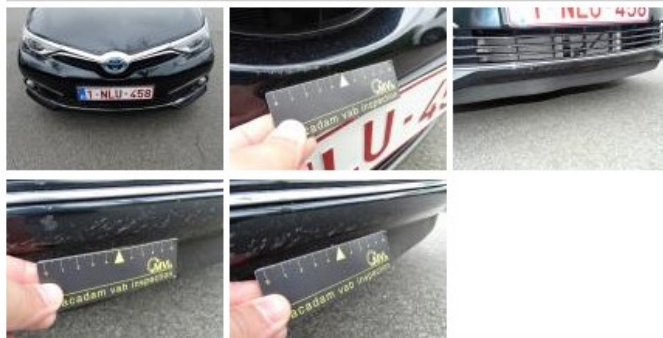
Front bumper, Scratch(es), LI - Repair and paint (complete) 211,80

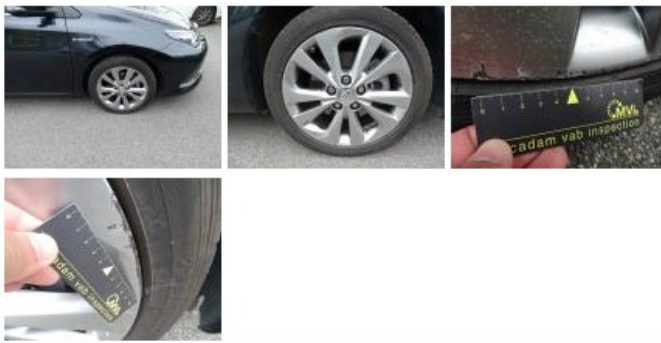
Alloy rim F R, Scratch(es), LI - Repair and paint (complete) 95,00
