AUDI A3 SPORTBACK: 1FMU012

Limited Technical Inspection

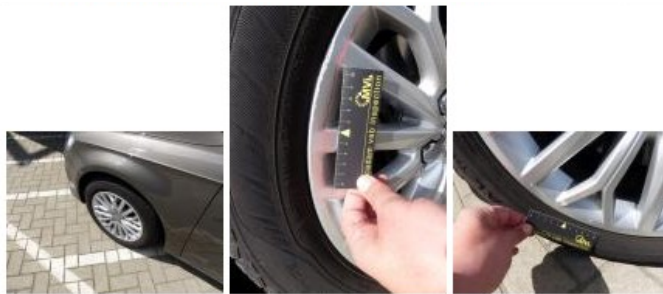
Alloy rim F L, Scratch(es), LI - Repair and paint (complete)	95,00
--	-------

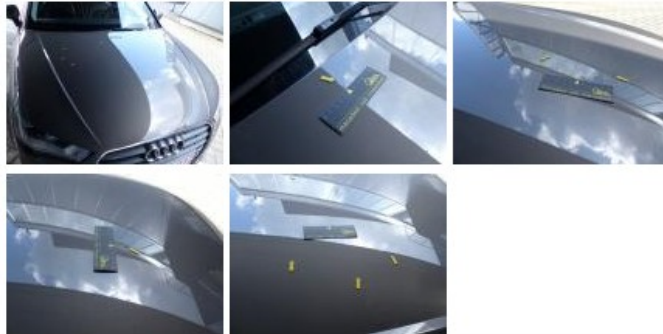
Bonnet, Hail damage, PDR - Hail 500,00

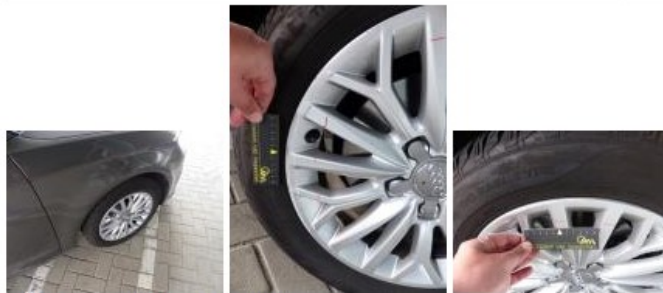
Alloy rim F R, Scratch(es), LI - Repair and paint (complete) 95,00

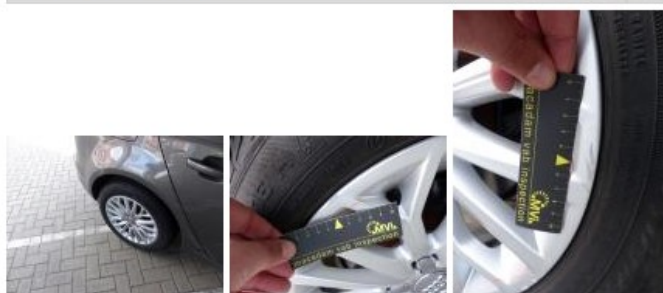
Alloy rim R R, Scratch(es), LI - Repair and paint (complete) 95,00
