**AUDI A5: 1HRT312**

**Limited Technical Inspection**

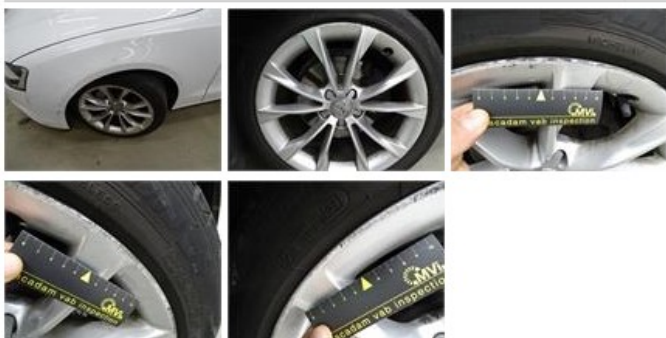
Alloy rim F L, Scratch(es), LI - Repair and paint (complete)	95,00
--	-------

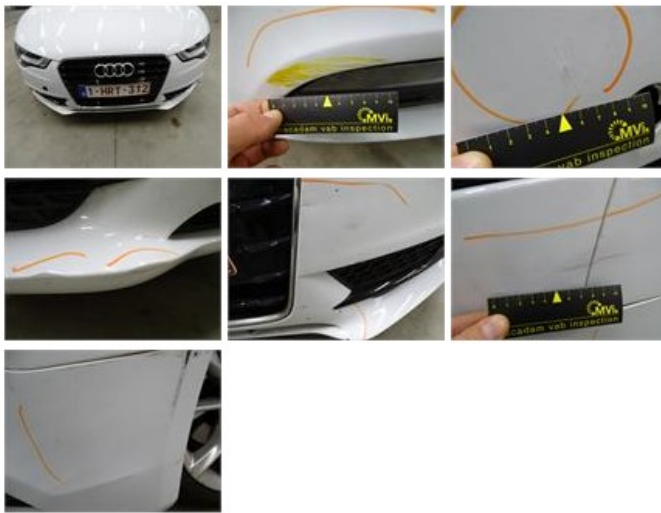
Wing F L, Bump(s) and scratch(es), LI - Repair and paint (complete)

Alloy rim R R, Scratch(es), LI - Repair and paint (complete)	95,00	
				Sill outer L, Bump(s) and scratch(es), LI - Repair and paint (complete)	372,60
			Rearview mirror housing L, Scratch(es), LI - Repair and paint (complete)	115,56	
			Bonnet, Chemical pollution, LI - Repair and paint (complete)	348,09	
			Alloy rim F R, Scratch(es), LI - Repair and paint (complete)	95,00	
				Door R L, Bump(s), PDR - Knock out without painting	63,00
			Door R R, Bump(s), LI - Repair and paint (complete)	382,02	
			Front bumper, Bump(s) and scratch(es), LI - Repair and paint (complete)	254,16

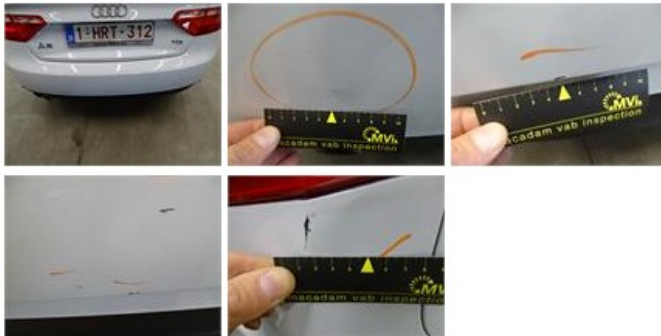
Bumper R, Bump(s) and scratch(es), LI - Repair and paint (complete) 254,16
