BMW 3: 1FXC249

Vinnumber:	WBA3D91030J413199	Versionname:	3 BER 316d 116PK
First Registrationdate:	25/11/2013	Fiscalpower:	
Expertise Mileage:	75072	Power Kw:	85
Bodytype:		Body color:	Brown
Gearbox:	MAN 6 VIT	Paint type:	Metalic
Transmission:	Back	Rims summer:	Aluminium
Fueltype:	Diesel	Oil level:	OK
Maintenance:	OK	Parking lot:	1428
Maintenance:	12000 KM		
Battery functioning:	Yes		
Number of doors:	4		
Number of seats:	5		
Number head rests:	5		
Rims summer:	Aluminium		
Category:	Passenger Car		
Oil level:	OK		
Registration Certificate Car (BE):	Yes

Limited Technical Inspection

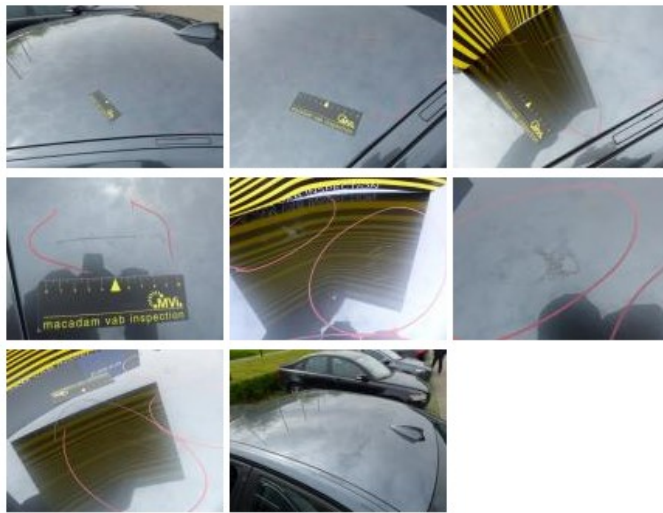
Roof, Chemical pollution, LI - Repair and paint (complete)	481,50
