BMW 1: 1GNP823

Limited Technical Inspection

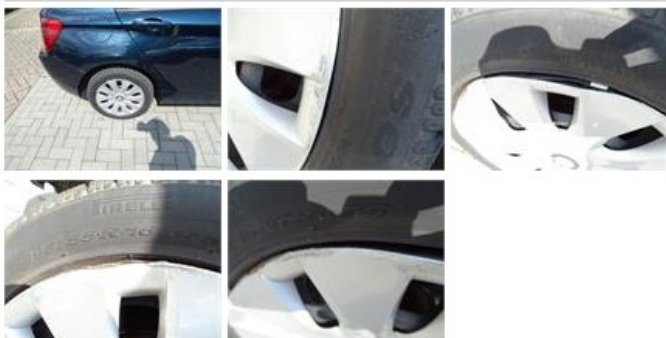
Wheel cover R R, Damaged, E - Replace

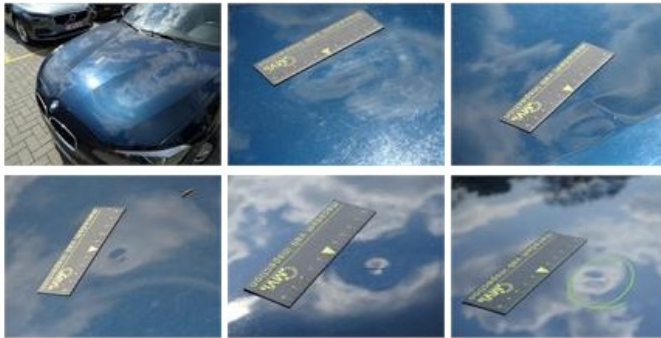
Bonnet, Bump(s), PDR - Knock out without painting 225,60

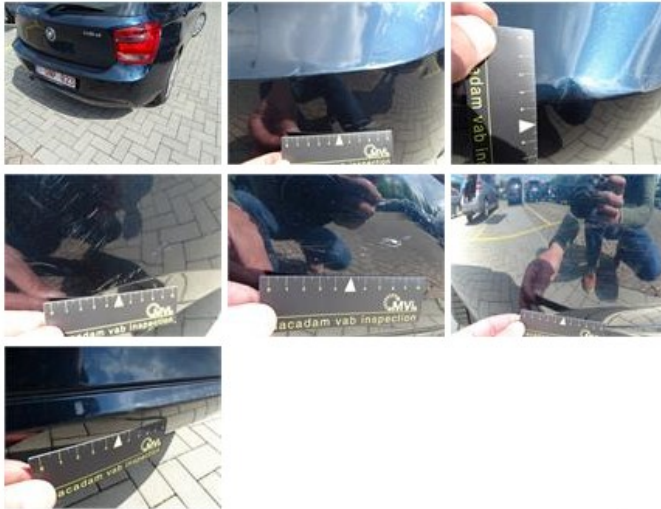
Bumper R, Bump(s) and scratch(es), LI - Repair and paint (complete) 211,80
