**BMW 5: 1GRY581**

**Limited Technical Inspection**

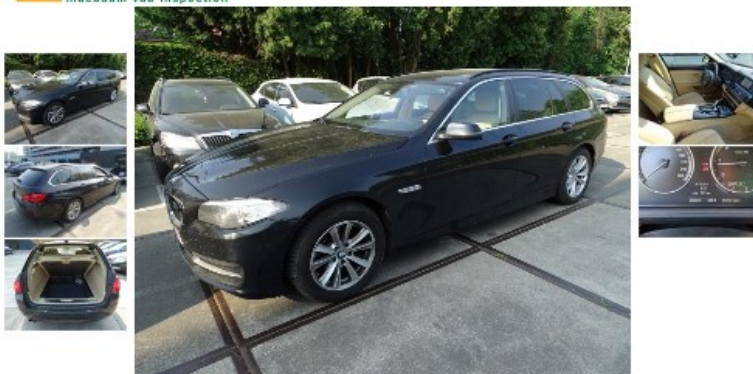
Wing F L, Scratch(es), LI - Repair and paint (complete)	<b>264,21</b>
---	---------------
