MERCEDES A: 1FDU791			
Vinnnumber:	<b>WDD1760121J119620</b>	Versionname:	<b>A 180 CDI BE 109PK</b>
First Registrationdate:	<b>3/06/2013</b>	Fiscalpower:	
Expertise Mileage:	<b>181491</b>	Power Kw:	<b>80</b>
Bodytype:		Body color	<b>Light Grey</b>
Gearbox:	<b>MAN 6 VIT</b>	Paint type	<b>Metalic</b>
Transmission:		Rims summer	<b>Aluminium</b>
Fueltype:	<b>Diesel</b>	Oil level	<b>OK</b>
Battery functioning	<b>Yes</b>	Parking lot	<b>1330</b>
Number of doors	<b>5</b>		
Number of seats	<b>5</b>		
Number head rests	<b>5</b>		
Rims summer	<b>Aluminium</b>		
Category	<b>Passenger Car</b>		
Oil level	<b>OK</b>

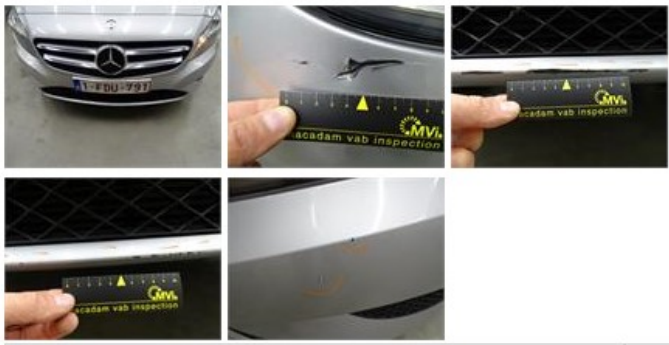
Front bumper, Bump(s) and scratch(es), LI - Repair and paint (complete) 211,80

Front bumper, Bump(s) and scratch(es), LI - Repair and paint (complete)

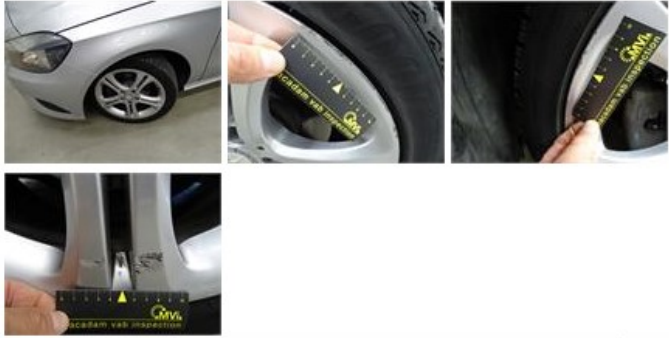
Alloy rim F L, Scratch(es), LI - Repair and paint (complete) 95,00
