PEUGEOT 3008: 1EDX329			
Vinnnumber:	VF30U9HR8CS239667	Versionname:	3008 Allure FAP 112PK
First Registrationdate:	2/11/2012	Fiscalpower:	
Expertise Mileage:	139628	Power Kw:	82
Bodytype:		Body color:	Grey
Gearbox:	MAN 6 VIT	Paint type:	Metalic
Transmission:		Rims summer:	Aluminium
Fueltype:	Diesel	Oil level:	OK
Battery functioning:	Yes	Parking lot:	1710
Number of doors:	5		
Number of seats:	5		
Number head rests:	5		
Rims summer:	Aluminium		
Category:	Passenger Car		
Oil level:	OK

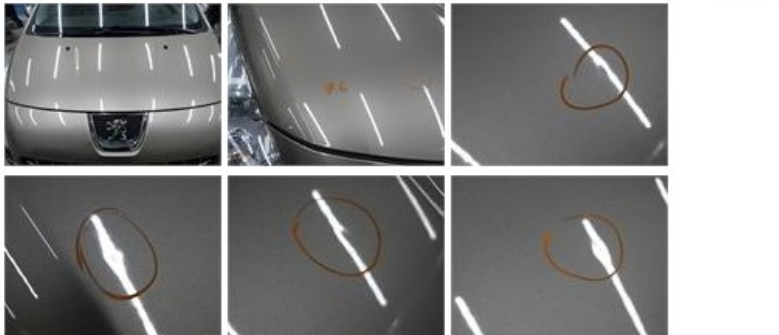
Total cost ex VAT	1215,18
Rocker panel inner R L, Scratch(es), Acceptable	0,00
<i>No pictures to display</i>	
Bonnet, Hail damage, PDR - Hail	150,00

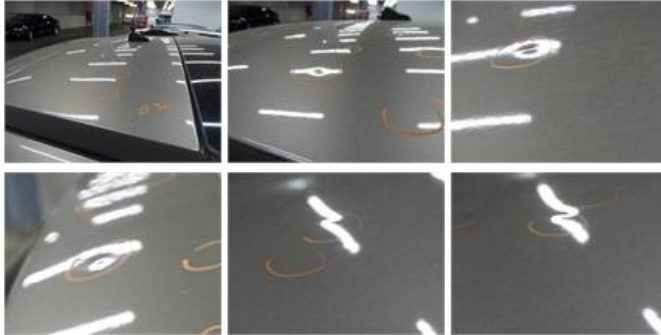
Roof, Hail damage, PDR - Hail 750,00
