VOLKSWAGEN Golf: 1GFQ538

Limited Technical Inspection

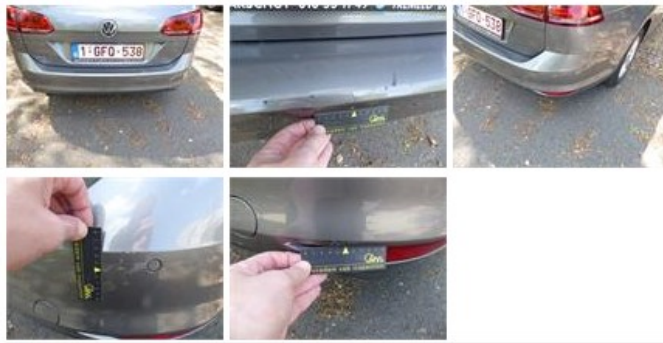
Bumper R, Scratch(es), LI - Repair and paint (complete) 211,80
