**TOYOTA Avensis: 1ERM205**

**Limited Technical Inspection**

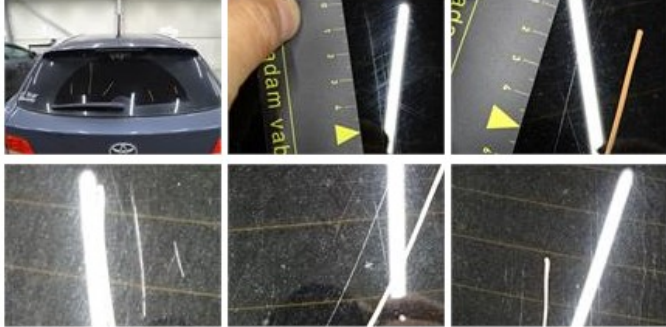
Rear window, Scratch(es), E - Replace	<b>0,00</b>
---------------------------------------	-------------

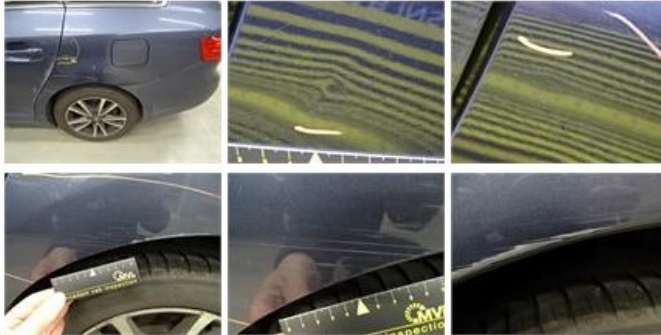
Wing R L, Bump(s) and scratch(es), LI - Repair and paint (complete) 308,20

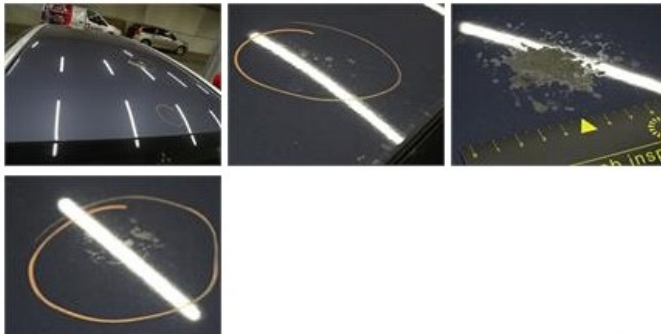
Roof, Chemical pollution, LI - Repair and paint (complete) 481,50

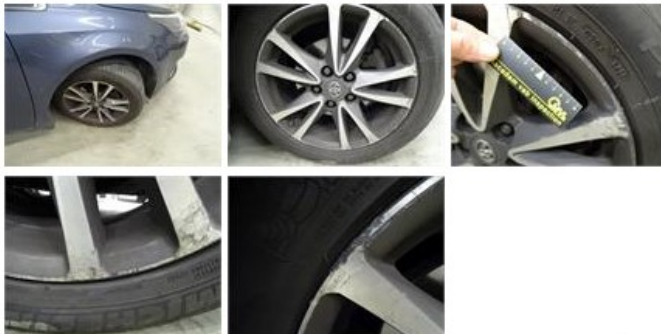
Alloy rim F R polished, Scratch(es), LI - Repair and paint (complete) 95,00

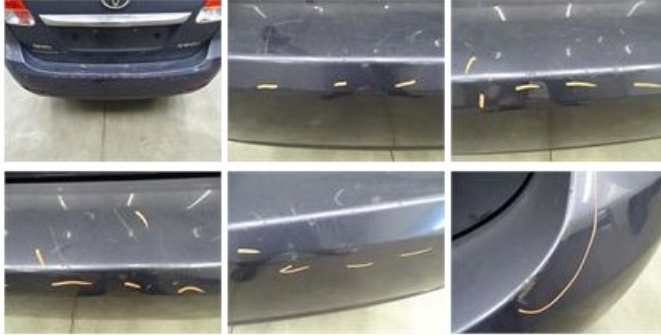
Alloy rim R L polished, Scratch(es), Acceptable	0,00
<i>No pictures to display</i>	
Alloy rim F L polished, Scratch(es), Acceptable	0,00
<i>No pictures to display</i>	
Bumper R, Scratch(es), LI - Repair and paint (complete)	211,80
