VOLVO V70: 1FHT043

Limited Technical Inspection

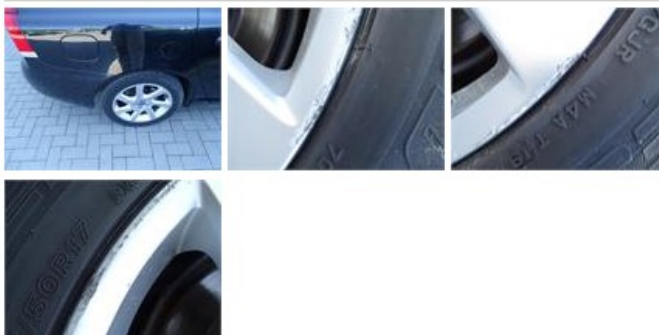
Alloy rim R R, Scratch(es), LI - Repair and paint (complete)	95,00
--	--------------

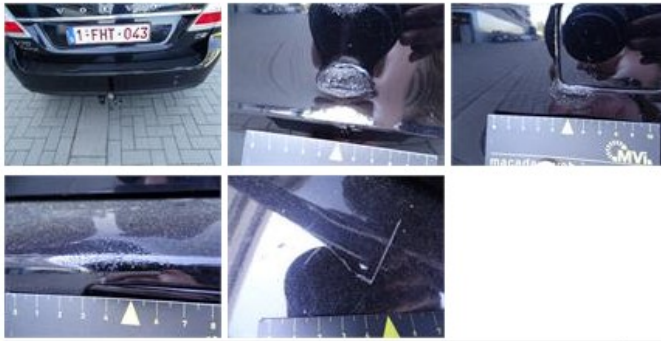
Bumper R, Damaged, E - Replace 483,84

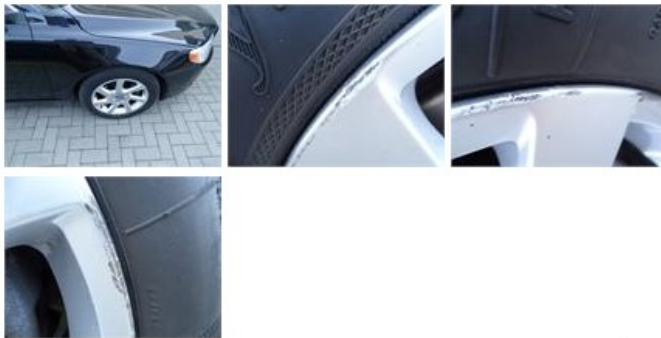
Alloy rim F L, Scratch(es), LI - Repair and paint (complete) 95,00
