VOLVO V40: 1ERW885			
Vinnumber:	YV1MV8481D2045856	Versionname:	V40 D2 Base 115PK
First Registrationdate:	5/03/2013	Fiscalpower:	
Expertise Mileage:	132417	Power Kw:	84
Bodytype:		Body color:	Black
Gearbox:	MAN 6 VIT	Paint type:	Metalic
Transmission:	Front	Rims summer:	Aluminium
Fueltype:	Diesel	Oil level:	OK
Maintenance:	OK	Parking lot:	4807
Battery functioning:	Yes		
Number of doors:	5		
Number of seats:	5		
Number head rests:	5		
Rims summer:	Aluminium		
Category:	Passenger Car		
Oil level:	OK

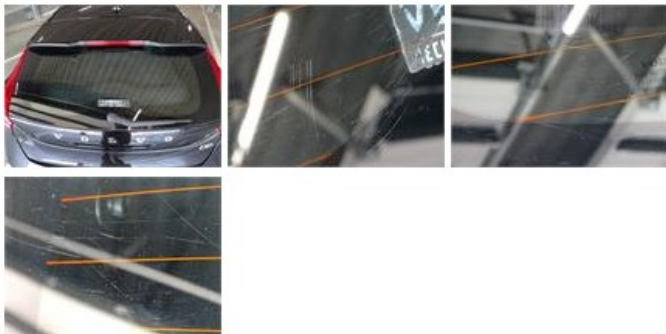
Total cost ex VAT	1674,20
Rear window, Scratch(es), E - Replace	370,00
