VOLKSWAGEN Touran: 1FOD481

Limited Technical Inspection

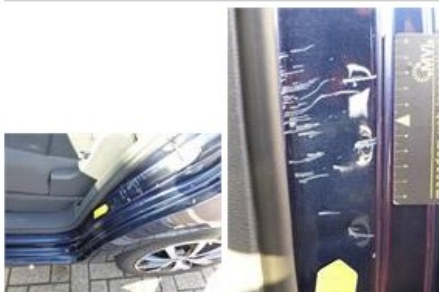
Door R L, Bump(s) and scratch(es), It - Spot repair	115,56
---	--------

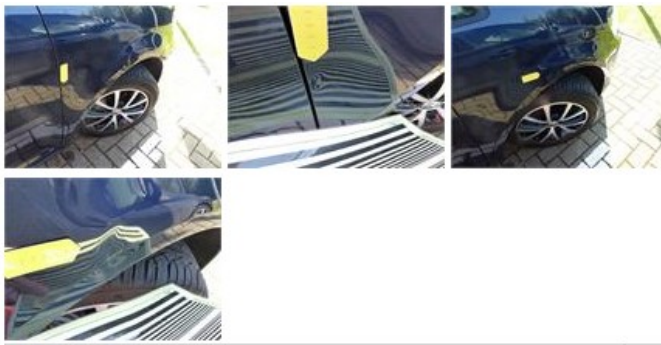
Wing F R, Bump(s), LI - Repair and paint (complete)

268,18

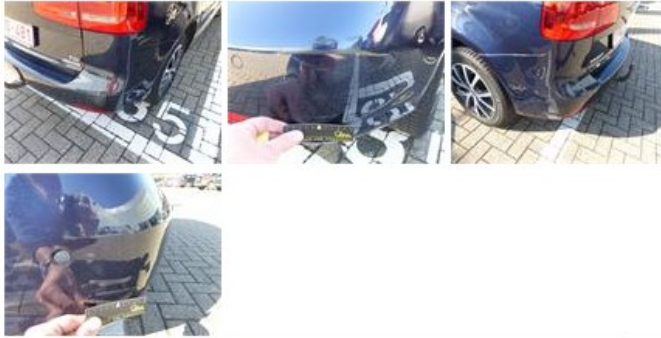
Bumper R, Scratch(es), LI - Repair and paint (complete) 211,80

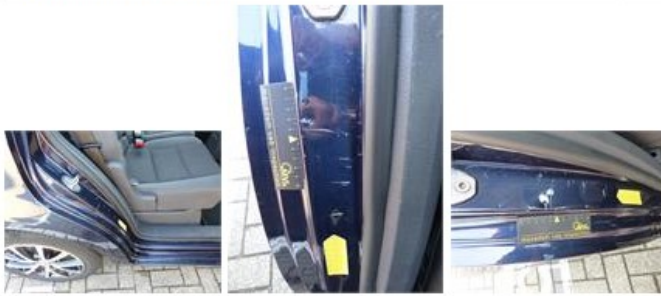
Door R R, Bump(s) and scratch(es), It - Spot repair 115,56

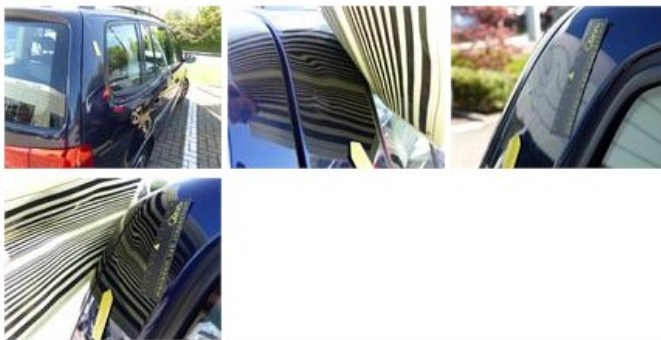
Wing R R, Bump(s), LI - Repair and paint (complete) 356,20
