BMW 3: 1FH0600

Limited Technical Inspection

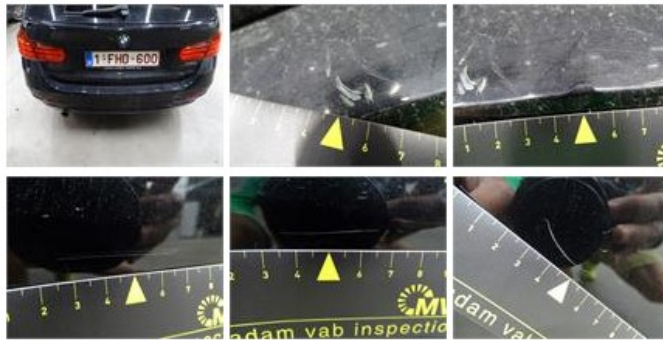
Bumper R, Scratch(es), LI - Repair and paint (complete) 211,80
