**BMW 1: 1FAN376**

**Limited Technical Inspection**

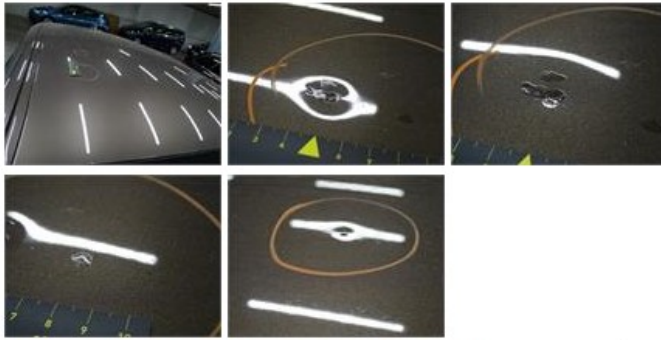
Roof, Bump(s) and scratch(es), LI - Repair and paint (complete) 481,50

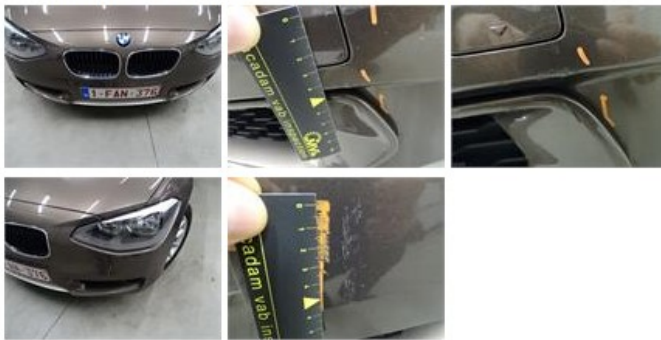
Front bumper, Scratch(es), LI - Repair and paint (complete) 211,80

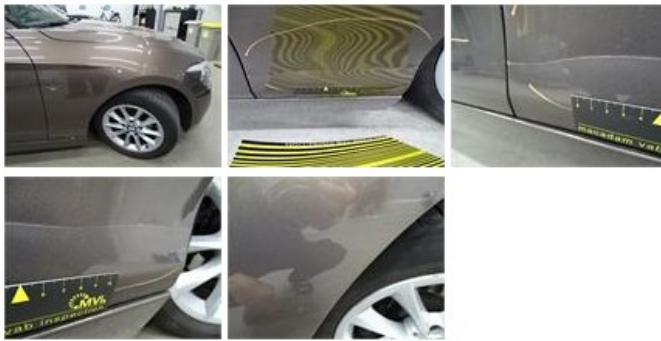
Wing F R, Bump(s) and scratch(es), LI - Repair and paint (complete) 220,18
