**BMW SERIE 5 TOURING: 1GRY578**

Vinnumber:	<b>WBA5J11020D336052</b>	Versionname:	<b>518 D</b>
First Registrationdate:	<b>11/04/2014</b>	Fiscalpower:	
Expertise Mileage:	<b>101281</b>	Power Kw:	<b>100</b>
Bodytype:		Body color:	<b>Grey</b>
Gearbox:	<b>MAN 6 VIT</b>	Paint type:	<b>Metalic</b>
Transmission:	<b>Back</b>	Rims summer:	<b>Aluminium</b>
Fueltype:	<b>Diesel</b>	Oil level:	<b>OK</b>
Maintenance:	<b>IN 20000 KM</b>	Parking lot:	<b>1509</b>
Maintenance:	<b>OK</b>		
Battery functioning:	<b>Yes</b>		
Number of doors:	<b>5</b>		
Number of seats:	<b>5</b>		
Number head rests:	<b>5</b>		
Rims summer:	<b>Aluminium</b>		
Category:	<b>Passenger Car</b>		
Oil level:	<b>OK</b>		
Registration Certificate Car (BE):	<b>Yes</b>

**Limited Technical Inspection**

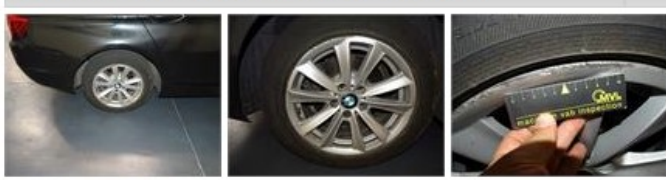
Alloy rim R R, Scratch(es), LI - Repair and paint (complete)	<b>95,00</b>
--	--------------
