BMW 3: 1EXQ634

Limited Technical Inspection

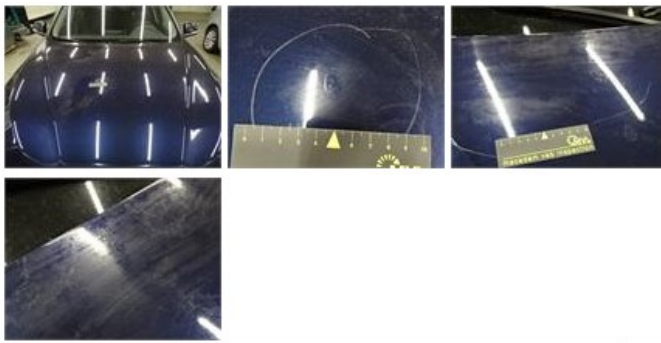
Bonnet, Scratch(es), LI - Repair and paint (complete)	290,08
---	---------------

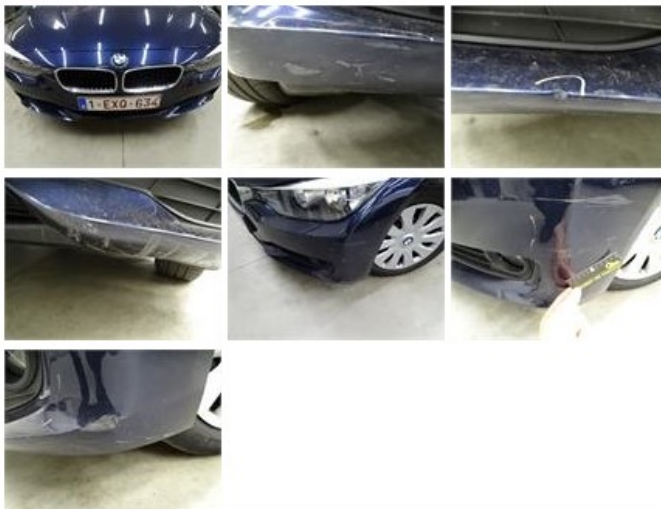
Front bumper, Bump(s) and scratch(es), LI - Repair and paint (complete) 211,80

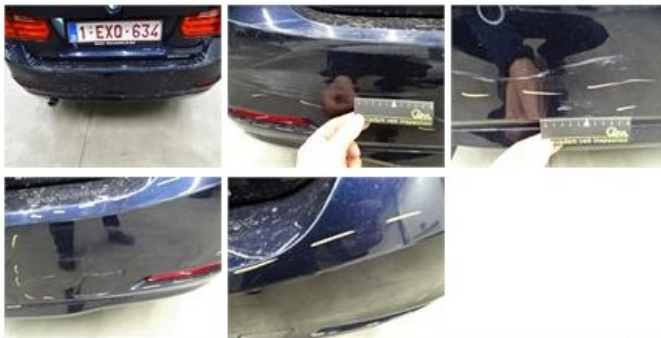
Bumper R, Scratch(es), LI - Repair and paint (complete) 211,80

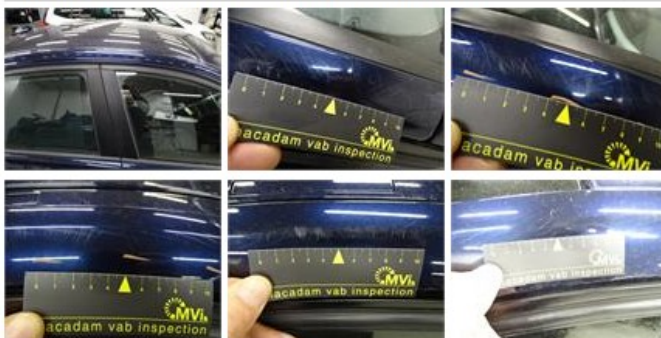
Roof pillar R, Scratch(es), LI - Repair and paint (complete) 220,18
