BMW 5: 1GSI228

Limited Technical Inspection

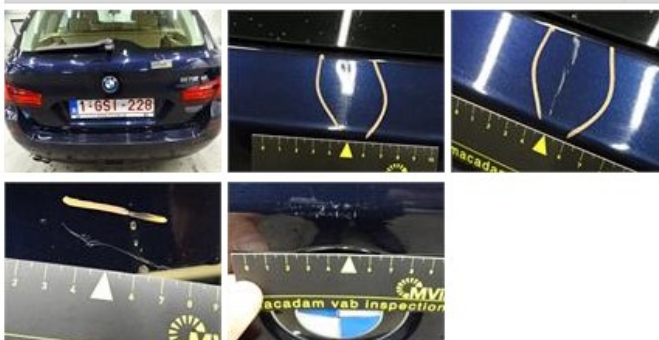
Tailgate, Bump(s) and scratch(es), LI - Repair and paint (complete) 362,02

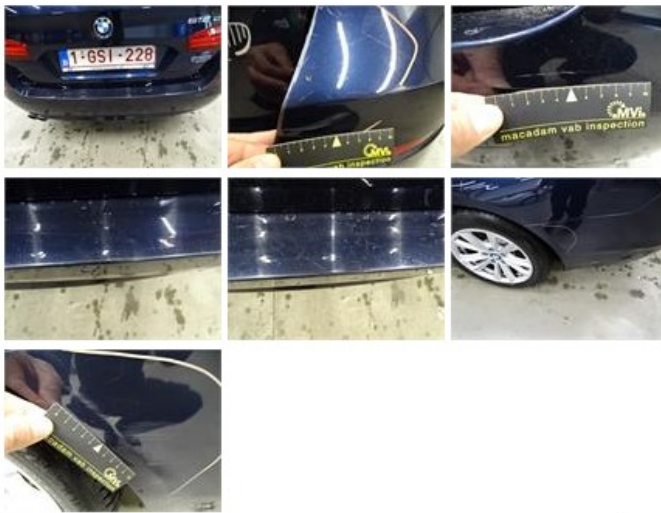
Bumper R, Scratch(es), LI - Repair and paint (complete)

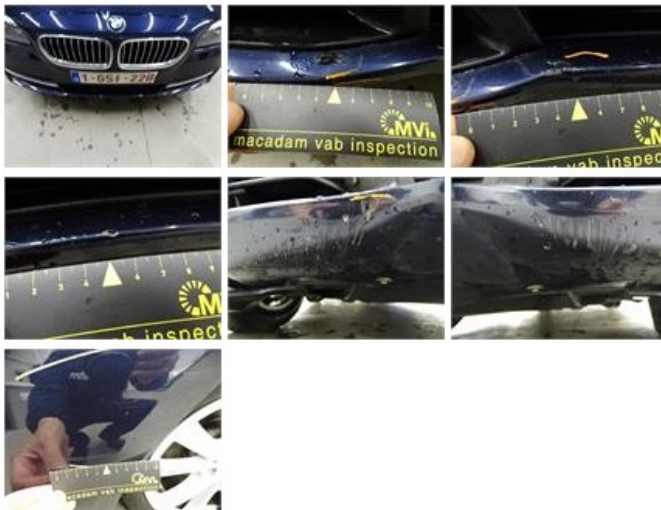
Front bumper, Bump(s) and scratch(es), LI - Repair and paint (complete) 254,16

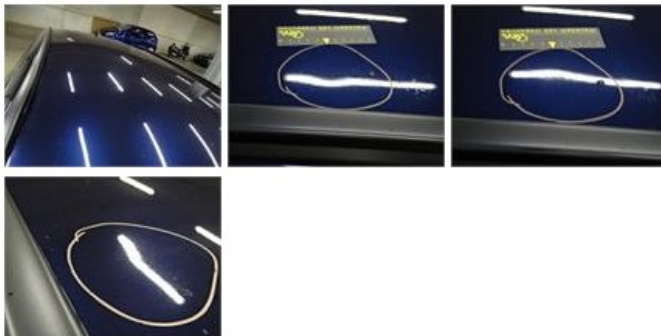
Roof, Bump(s), PDR - Knock out without painting 63,00

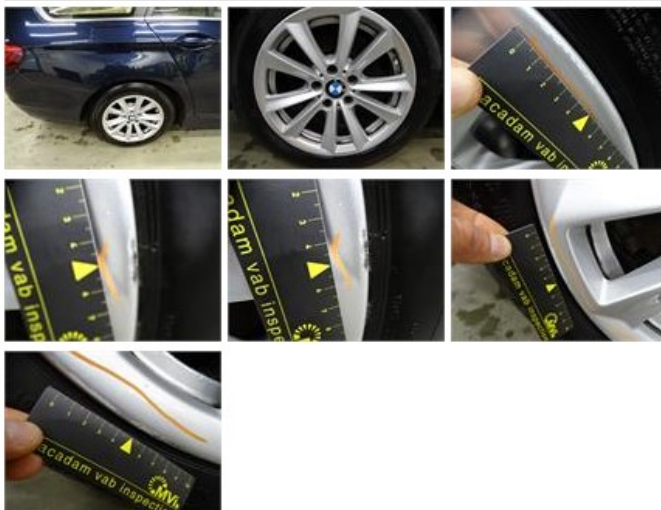
Alloy rim R R, Scratch(es), LI - Repair and paint (complete) 95,00

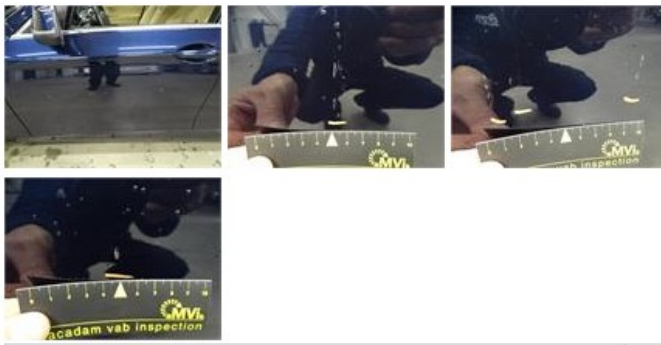
Door F L, Scratch(es), LI - Repair and paint (complete) 382,02

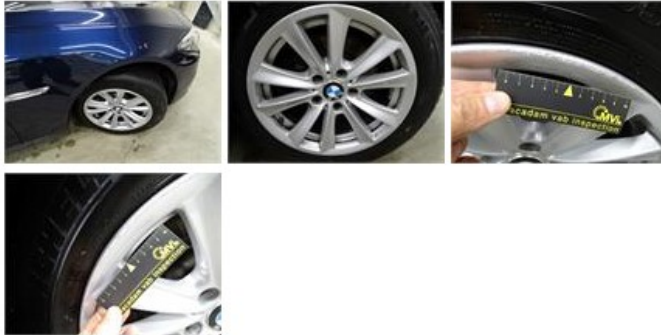
Alloy rim F R, Scratch(es), LI - Repair and paint (complete) 95,00

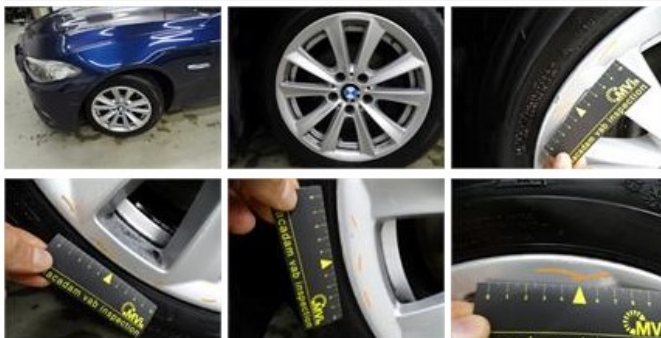
Alloy rim F L, Scratch(es), LI - Repair and paint (complete) 95,00

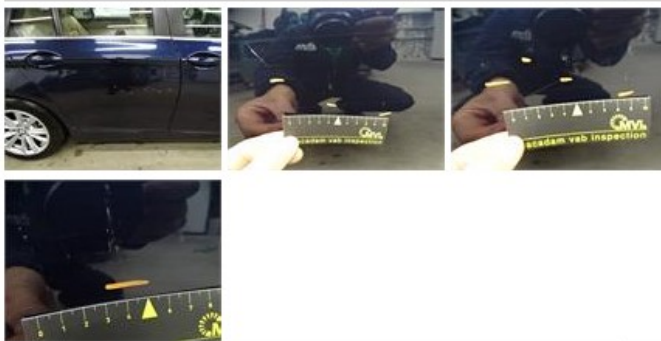
Door R R, Scratch(es), LI - Repair and paint (complete) 382,02
