**MERCEDES A: 1JHT487**

**Limited Technical Inspection**

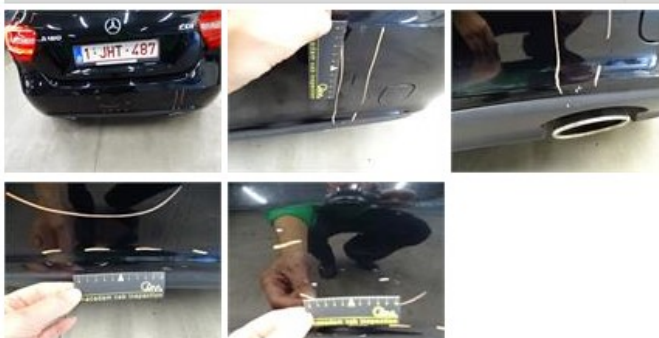
Repair kit	<b>Yes</b>	Compressor	<b>Yes</b>
Total cost ex VAT			3033,79
Bumper R, Bump(s) and scratch(es), LI - Repair and paint (complete)			211,80

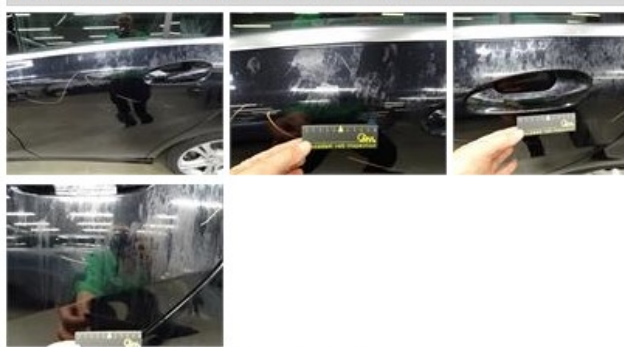
Door R L, Chemical polution, LI - Repair and paint (complete)	318,35

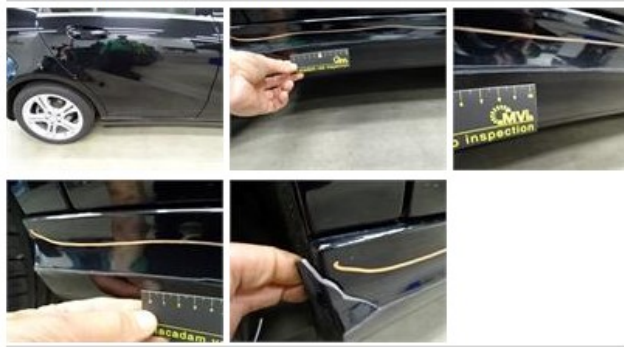
Sill outer R, Damaged, Le - Replace and paint	712,00

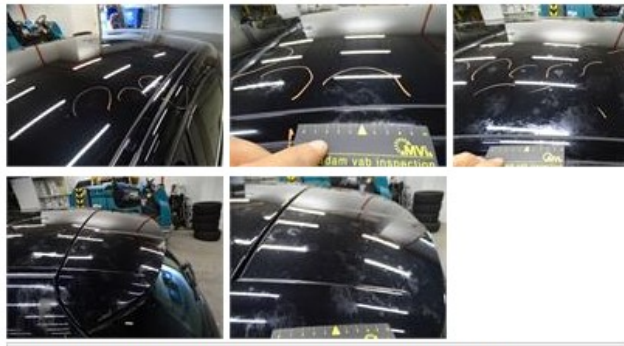
Roof, Chemical polution, LI - Repair and paint (complete)	481,50

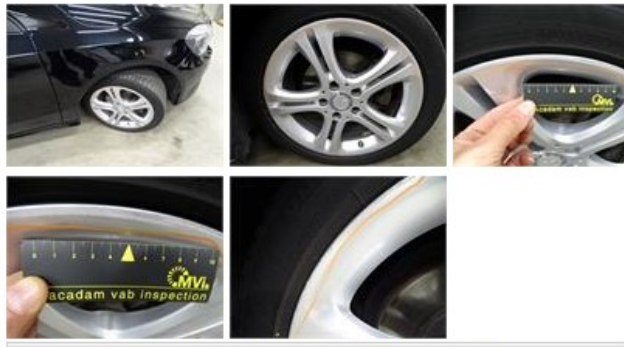
Alloy rim F R, Scratch(es), LI - Repair and paint (complete)	95,00
