MERCEDES A: 1GAS718			
Vinnumber:	WDD1760121J224060	Versionname:	A 180 CDI BE 109PK
First Registrationdate:	10/12/2013	Fiscalpower:	
Expertise Mileage:	62701	Power Kw:	80
Bodytype:		Body color:	Brown
Gearbox:	MAN 6 VIT	Paint type:	Metalic
Transmission:	Front	Rims summer:	Aluminium
Fueltype:	Diesel	Oil level:	OK
Maintenance:	OK	Parking lot:	2616
Battery functioning:	Yes		
Number of doors:	5		
Number of seats:	5		
Number head rests:	5		
Rims summer:	Aluminium		
Category:	Passenger Car		
Oil level:	OK		
Registration Certificate Car (BE):	Yes

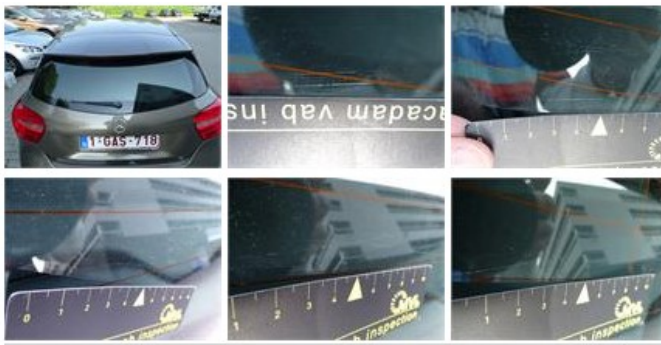
Rear window, Scratch(es), E - Replace	370,00
--	---------------
