**OPEL Astra BREAK: 1FAN343**

**Limited Technical Inspection**

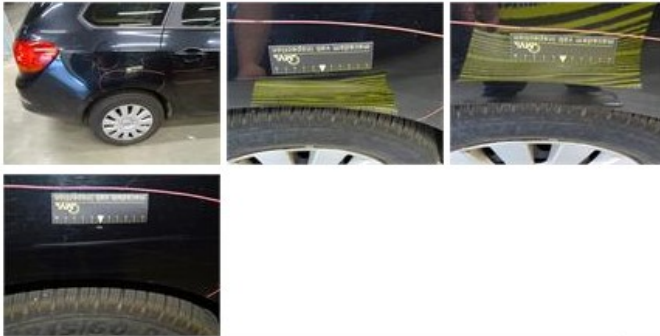
Wing R R, Bump(s) and scratch(es), LI - Repair and paint (complete) 428,20

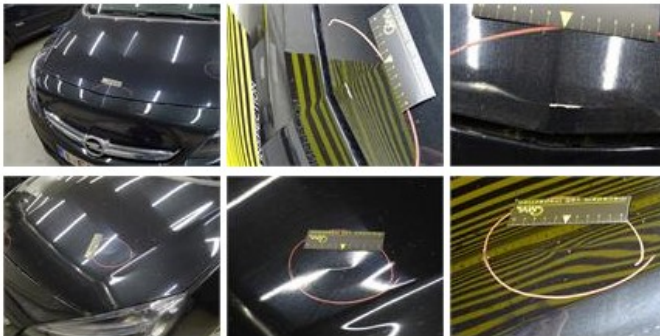
Bonnet, Bump(s) and scratch(es), LI - Repair and paint (complete) 338,08
