OPEL CASCADA: SF8335

Limited Technical Inspection

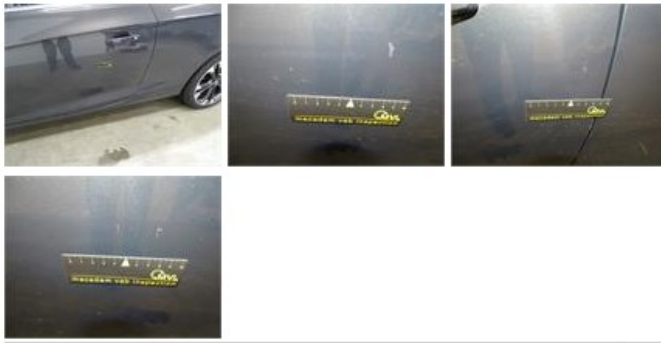
Door F L, Scratch(es), LI - Repair and paint (complete)	318,35
---	--------
