TOYOTA AURIS: 1NRF546			
Vinnumber:	SB1MS3JE10E247039	Versionname:	1.8 HYBRID LOUNGE CVT
First Registrationdate:	7/04/2016	Fiscalpower:	AUTO
Expertise Mileage:	47513	Power Kw:	73
Bodytype:		Body color:	GRIS
Gearbox:	Automatic	Body color:	Grey
Transmission:	Front	Paint type:	Metalic
Fueltype:	Hybrid Petrol	Rims summer:	Aluminium
Battery functioning:	Yes	Oil level:	OK
Number of doors:	5	Parking lot:	1328
Number of seats:	5		
Number head rests:	4		
Rims summer:	Aluminium		
Category:	Passenger Car		
Oil level:	OK		
Registration Certificate Car (BE):	Yes

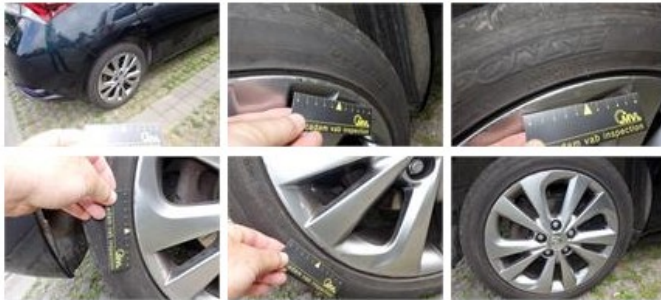
Alloy rim R R, Scratch(es), LI - Repair and paint (complete) 95,00

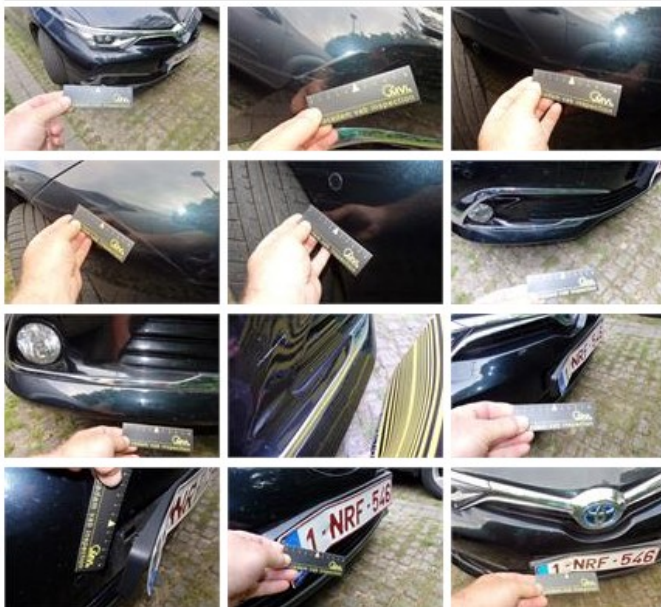
Front bumper, Bump(s) and scratch(es), LI - Repair and paint (complete) 211,80
