SKODA Superb: 1EFU888			
Vinnumber:	TMBJJ73T5D9029513	Versionname:	SUPERB COMBI GreenLin.Ambition DPF
First Registrationdate:	20/11/2012	Fiscalpower:	105PK
Expertise Mileage:	166477	Power Kw:	77
Bodytype:		Body color:	Brown
Gearbox:	MAN 5 VIT	Paint type:	Metalic
Transmission:	Front	Rims summer:	Aluminium
Fueltype:	Diesel	Oil level:	OK
Maintenance:	OK	Parking lot:	3226
Battery functioning:	Yes		
Number of doors:	5		
Number of seats:	5		
Number head rests:	5		
Rims summer:	Aluminium		
Category:	Passenger Car		
Oil level:	OK

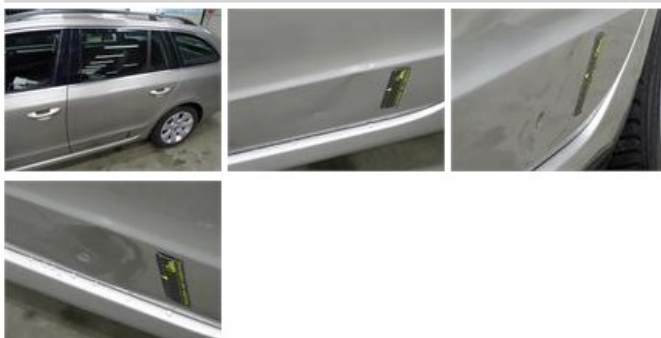
Total cost ex VAT	1579,50
Door R L, Bump(s), LI - Repair and paint (complete)	382,02
