<b>VOLVO XC60: 1DDT411</b>			
Vinnnumber:	<b>YV1DZ88A1C2335825</b>	Versionname:	<b>XC60 DRIVE Kinetic St/St</b>
First Registrationdate:	<b>18/04/2012</b>	Fiscalpower:	<b>163PK</b>
Expertise Mileage:	<b>113313</b>	Power Kw:	<b>120</b>
Bodytype:		Body color:	<b>Black</b>
Gearbox:	<b>MAN 6 VIT</b>	Paint type:	<b>Metalic</b>
Transmission:		Rims summer:	<b>Aluminium</b>
Fueltype:	<b>Diesel</b>	Oil level:	<b>OK</b>
Battery functioning:	<b>Yes</b>	Parking lot:	<b>1304</b>
Number of doors:	<b>5</b>		
Number of seats:	<b>5</b>		
Number head rests:	<b>5</b>		
Rims summer:	<b>Aluminium</b>		
Category:	<b>Passenger Car</b>		
Oil level:	<b>OK</b>

<b>Limited Technical Inspection</b>			
Airco functioning	<b>OK</b>	Battery functioning	<b>Yes</b>
Tires wear profile	<b>OK</b>	Power steering	<b>Yes</b>
Idle position	<b>OK</b>	Sound engine	<b>OK</b>
Engine startingtime	<b>OK</b>	Clutch test	<b>OK</b>
Exhaust gass	<b>OK</b>	Wiper fluid level	<b>OK</b>
Handbrake	<b>OK</b>	Transmission	<b>OK</b>
		Lighting	<b>OK</b>
		Wiperblades	<b>OK</b>

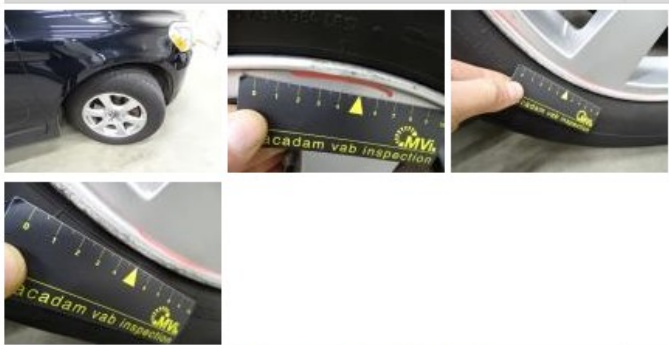
<b>Assistance equipment</b>			
Repair kit	<b>Yes</b>	Compressor	<b>Yes</b>
<b>Total cost ex VAT</b>			<b>667,02</b>
<b>Alloy rim F R, Scratch(es), LI - Repair and paint (complete)</b>			<b>95,00</b>

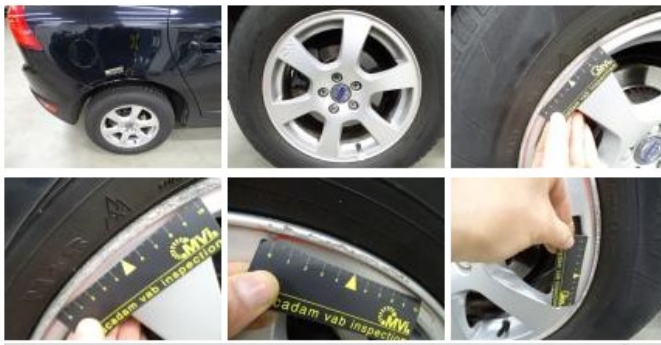
<b>Alloy rim R R, Scratch(es), LI - Repair and paint (complete)</b>			<b>95,00</b>
---	--	--	--------------
