VOLVO V40: 1GQF145			
Vinnnumber:	<b>YV1MV8481E2137660</b>	Versionname:	<b>V40 D2 Base 115PK</b>
First Registrationdate:	<b>1/04/2014</b>	Fiscalpower:	
Expertise Mileage:	<b>59800</b>	Power Kw:	<b>84</b>
Bodytype:		Body color:	<b>Light Grey</b>
Gearbox:	<b>MAN 6 VIT</b>	Paint type:	<b>Metalic</b>
Transmission:		Rims summer:	<b>Steel</b>
Fueltype:	<b>Diesel</b>	Oil level:	<b>OK</b>
Battery functioning:	<b>Yes</b>	Parking lot:	<b>2804</b>
Number of doors:	<b>5</b>		
Number of seats:	<b>5</b>		
Number head rests:	<b>5</b>		
Rims summer:	<b>Steel</b>		
Category:	<b>Passenger Car</b>		
Oil level:	<b>OK</b>		
Registration Certificate Car (BE):	<b>Yes</b>

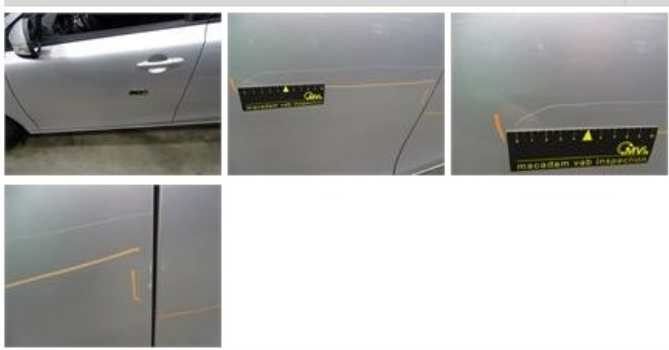
Assistance equipment	
Repair kit	<b>Yes</b>
Compressor	<b>Yes</b>
Total cost ex VAT	2723,56
Door F L, Scratch(es), LI - Repair and paint (complete)	318,35

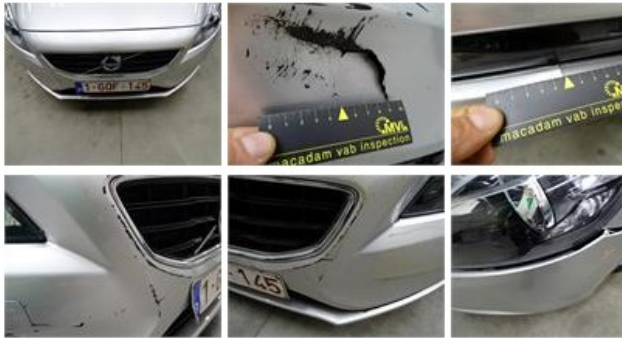
Front bumper, Damaged, Le - Replace and paint	735,00
