BMW 2 GRAN TOURER: CN6088

| Vinnumber: | WBA2D710005C39152 | Versionname: | 2.0 220D (140KW) XDRIVE GRAN TOURER |

Limited Technical Inspection

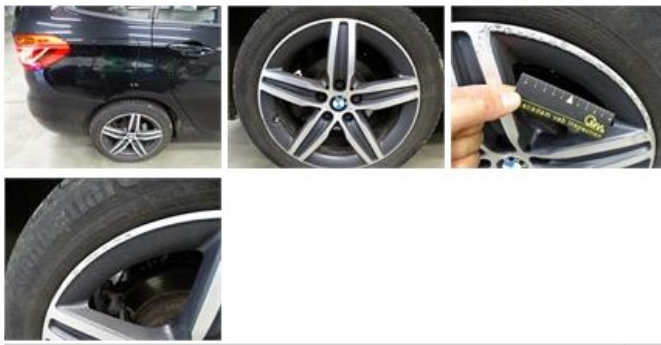
| Alloy rim R R polished, Scratch(es), LI - Repair and paint (complete) | 95,00 |

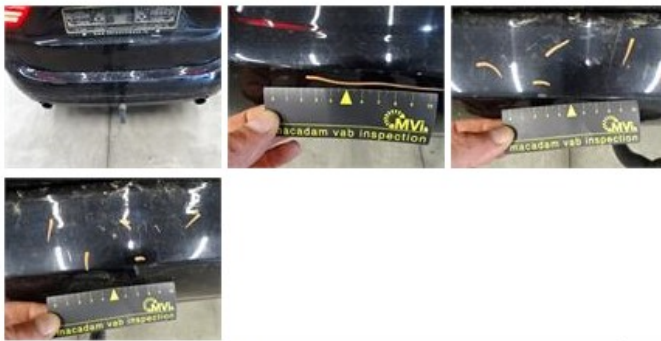
| Bumper R, Scratch(es), LI - Repair and paint (complete) | 211,80 |

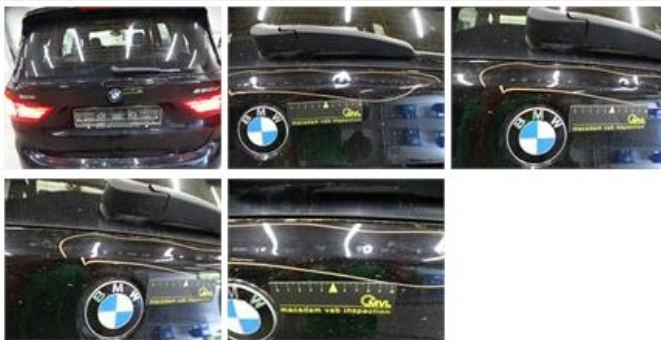
| Tailgate, Bump(s) and scratch(es), LI - Repair and paint (complete) | 301,68 |

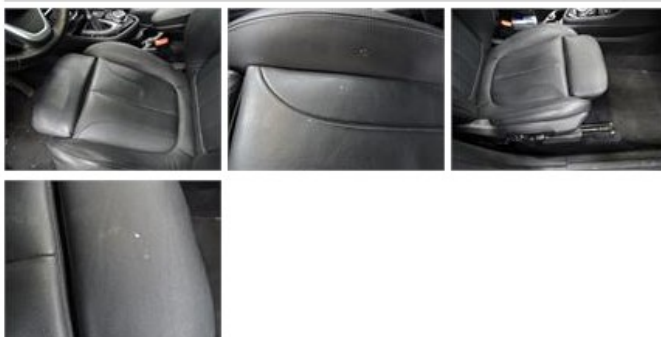
| Interior, Stain, Cleaning | 50,00 |
