BMW 1: 1GRP482

Limited Technical Inspection

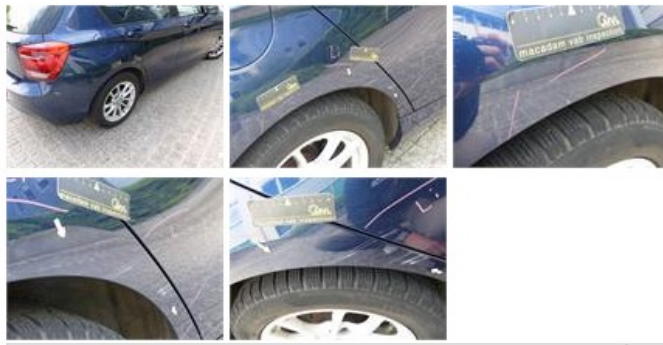
Total cost ex VAT	1006,35
Door R L, Bump(s) and scratch(es), Acceptable	0,00
<i>No pictures to display</i>	
Door F R, Bump(s) and scratch(es), Acceptable	0,00
<i>No pictures to display</i>	
Wing F L, Bump(s) and scratch(es), Acceptable	0,00
<i>No pictures to display</i>	
Wing R R, Damaged, LI - Repair and paint (complete)	404,20

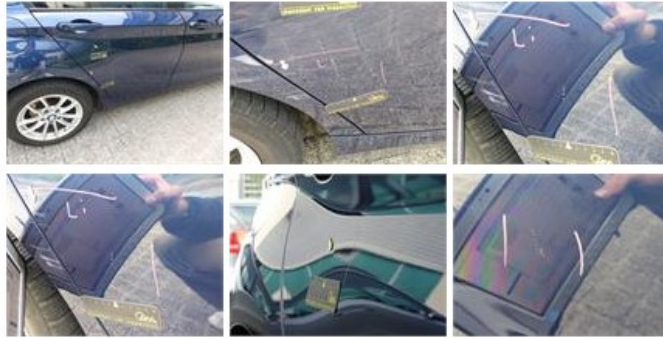
Door R R, Bump(s) and scratch(es), LI - Repair and paint (complete) 366,35

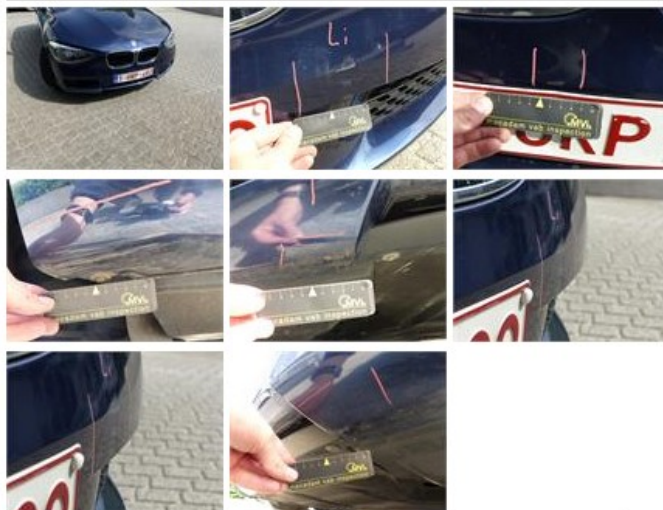
Front bumper, Bump(s) and scratch(es), LI - Repair and paint (complete) 235,80
