BMW 1: 1GWN825

Limited Technical Inspection

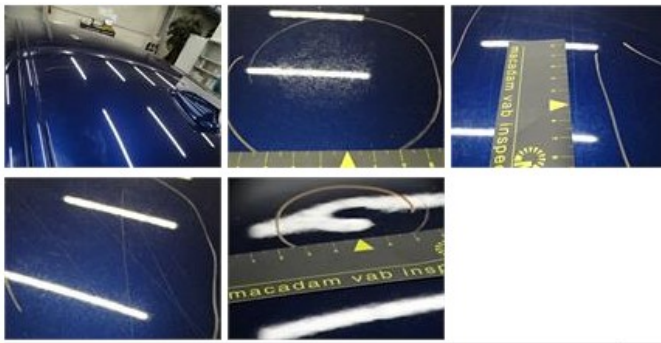
Roof, Chemical pollution, LI - Repair and paint (complete) 481,50

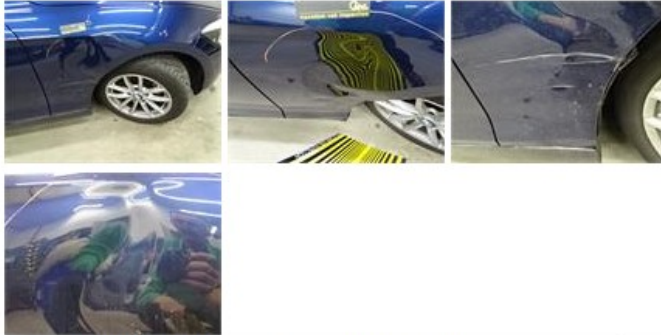
Wing F R, Bump(s) and scratch(es), Le - Replace and paint 530,02

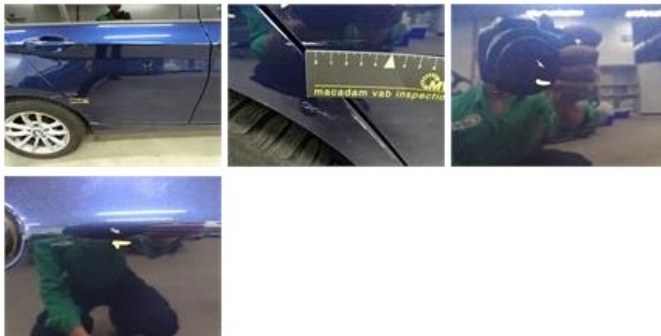
Door R R, Scratch(es), LI - Repair and paint (complete) 318,35

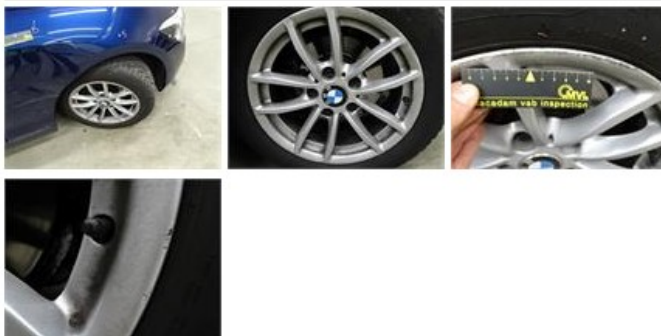
Alloy rim F R, Scratch(es), LI - Repair and paint (complete) 95,00
