BMW 3: 1FCY739

| Vinnumber: | WBA3K91040F930696 | Versionname: | 3 TOURING 316d 116PK |

Limited Technical Inspection

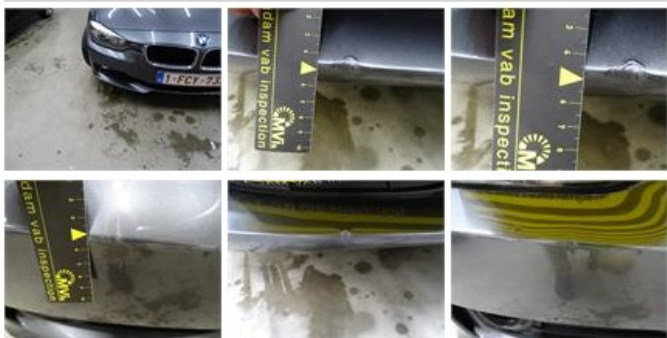
| Front bumper, Bump(s), LI - Repair and paint (complete) | 211,80 |
