**BMW 5: 1GUH322**

**Limited Technical Inspection**

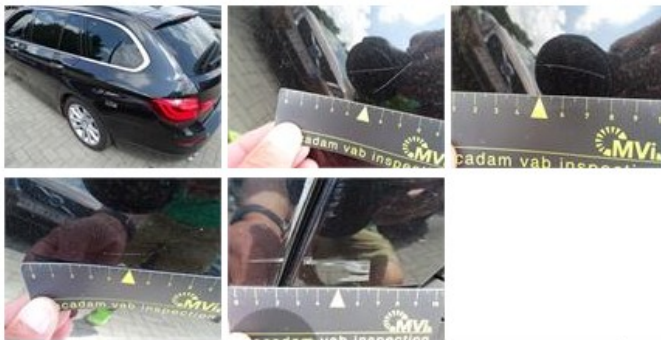
Wing R L, Scratch(es), LI - Repair and paint (complete) 369,84
