OPEL Vivaro 2700: 1FTZ385

Limited Technical Inspection

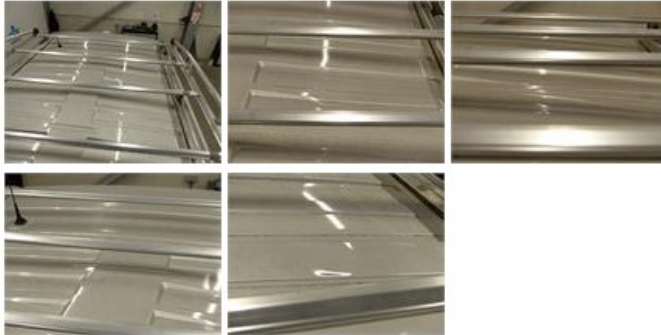
Roof, Bump(s), LI - Repair and paint (complete) 433,13

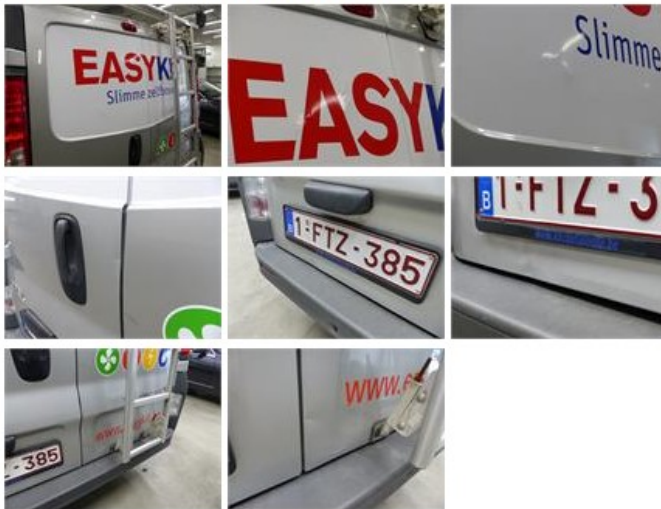
Tailgate, Bump(s), LI - Repair and paint (complete) 458,02

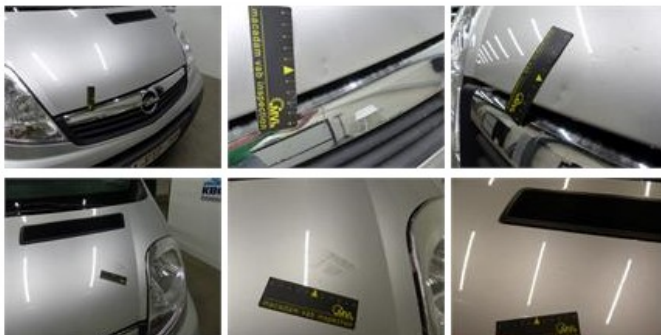
Bonnet, Bump(s) and scratch(es), LI - Repair and paint (complete) 217,56
