<b>MINI Countryman: 1AMJ344</b>			
Vinnumber:	<b>WMWZD31060WK46900</b>	Versionname:	<b>MINI COUNTRYMAN Cooper D DPF 112PK</b>
First Registrationdate:	<b>8/02/2011</b>	Fiscalpower:	
Expertise Mileage:	<b>141100</b>	Power Kw:	<b>82</b>
Bodytype:		Body color:	<b>Red</b>
Gearbox:	<b>MAN 6 VIT</b>	Paint type:	<b>Opaque</b>
Transmission:	<b>Front</b>	Rims summer:	<b>Aluminium</b>
Fueltype:	<b>Diesel</b>	Oil level:	<b>OK</b>
Maintenance:	<b>OK</b>	Parking lot:	<b>4233</b>
Battery functioning:	<b>Yes</b>		
Number of doors:	<b>5</b>		
Number of seats:	<b>5</b>		
Number head rests:	<b>5</b>		
Rims summer:	<b>Aluminium</b>		
Category:	<b>Passenger Car</b>		
Oil level:	<b>OK</b>

<b>Limited Technical Inspection</b>			
Airco functioning	<b>OK</b>	Battery functioning	<b>Yes</b>
Tires wear profile	<b>OK</b>	Power steering	<b>Yes</b>
Idle position	<b>OK</b>	Sound engine	<b>OK</b>
Engine startingtime	<b>OK</b>	Clutch test	<b>OK</b>
Exhaust gass	<b>OK</b>	Wiper fluid level	<b>OK</b>
Handbrake	<b>OK</b>	Transmission	<b>OK</b>
		Lighting	<b>OK</b>
		Wiperblades	<b>OK</b>

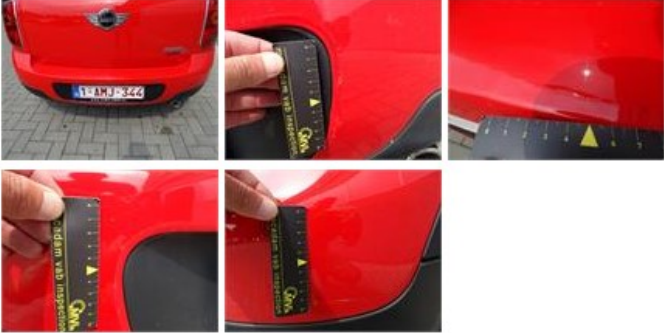
Bumper R, Bump(s) and scratch(es), LI - Repair and paint (complete)	211,80
