RENAULT Clio: 1GVV881

Limited Technical Inspection

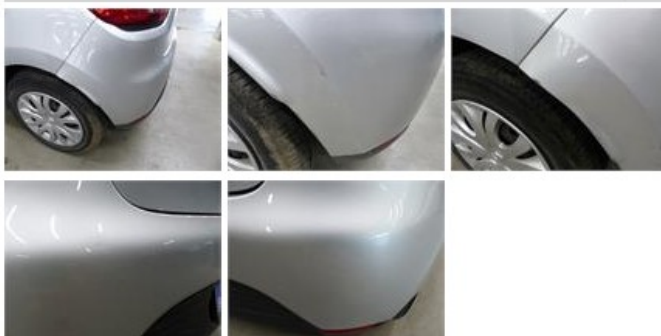
Bumper R, Bump(s) and scratch(es), LI - Repair and paint (complete)	193,44
---	--------
