RENAULT ESPACE: 1EUQ845

Limited Technical Inspection

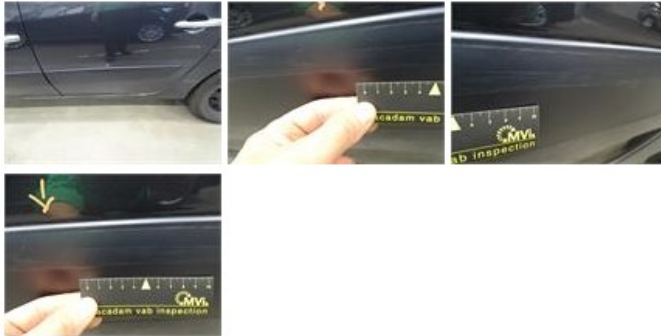
Door moulding Lower R L, Scratch(es), E - Replace 132,00

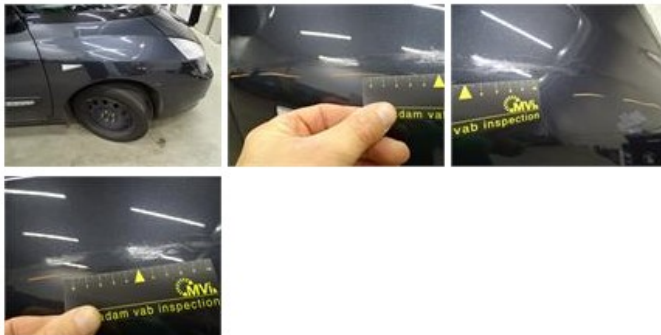
Wing F R, Scratch(es), LI - Repair and paint (complete) 264,21

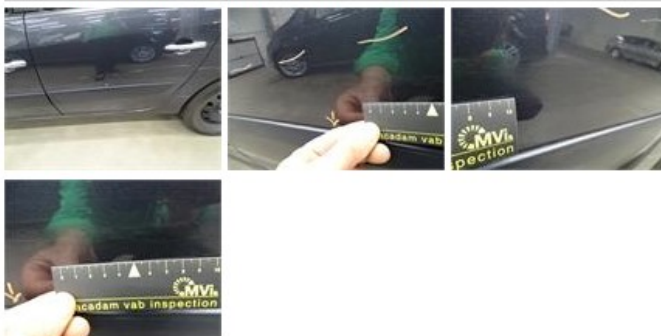
Door R L, Scratch(es), LI - Repair and paint (complete) 382,02

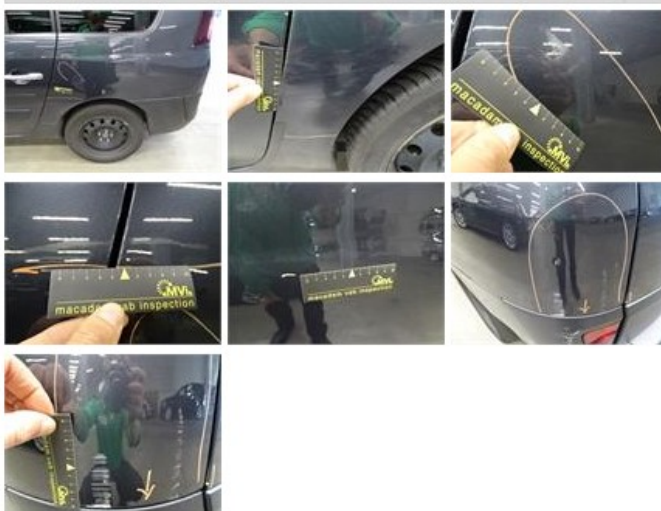
Wing R L, Scratch(es), LI - Repair and paint (complete) 369,84
