<b>PEUGEOT 2008: 1GWH538</b>			
Vinnumber:	<b>VF3CU8HR0EY006448</b>	Versionname:	<b>2008 Active 68PK</b>
First Registrationdate:	<b>19/05/2014</b>	Fiscalpower:	
Expertise Mileage:	<b>77500</b>	Power Kw:	<b>50</b>
Bodytype:		Body color:	<b>Grey</b>
Gearbox:	<b>MAN 5 VIT</b>	Paint type:	<b>Metalic</b>
Transmission:	<b>Front</b>	Rims summer:	<b>Aluminium</b>
Fueltype:	<b>Diesel</b>	Oil level:	<b>OK</b>
Maintenance:	<b>OK</b>	Parking lot:	<b>3425</b>
Battery functioning:	<b>Yes</b>		
Number of doors:	<b>5</b>		
Number of seats:	<b>5</b>		
Number head rests:	<b>5</b>		
Rims summer:	<b>Aluminium</b>		
Category:	<b>Passenger Car</b>		
Oil level:	<b>OK</b>		
Registration Certificate Car (BE):	<b>Yes</b>

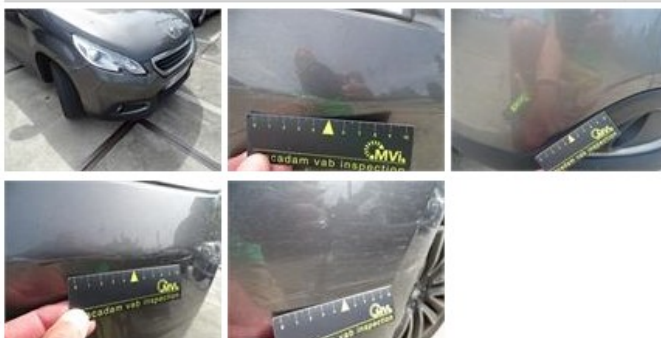
<b>Total cost ex VAT</b>	<b>1025,12</b>
<b>Front bumper, Scratch(es), LI - Repair and paint (complete)</b>	<b>211,80</b>
