## VOLVO V40: 1FCI208

## Limited Technical Inspection

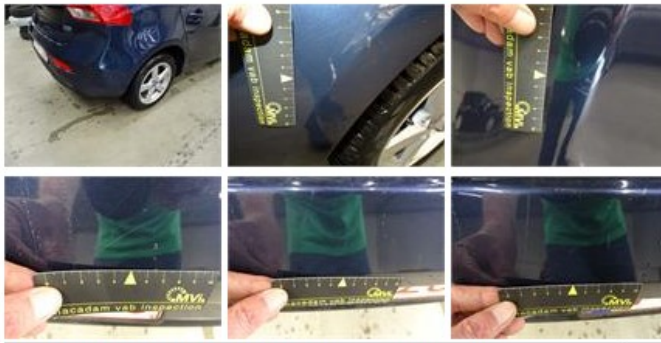
Bumper R, Bump(s) and scratch(es), LI - Repair and paint (complete)	<b>211,80</b>
---	---------------
