## VOLVO V40: 1EYJ505

## Limited Technical Inspection

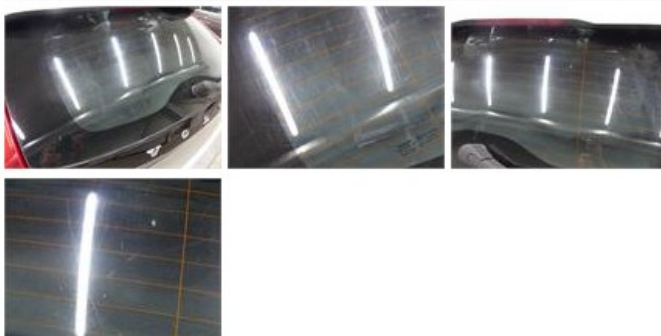
Rear window, Scratch(es), E - Replace	<b>370,00</b>
---------------------------------------	---------------

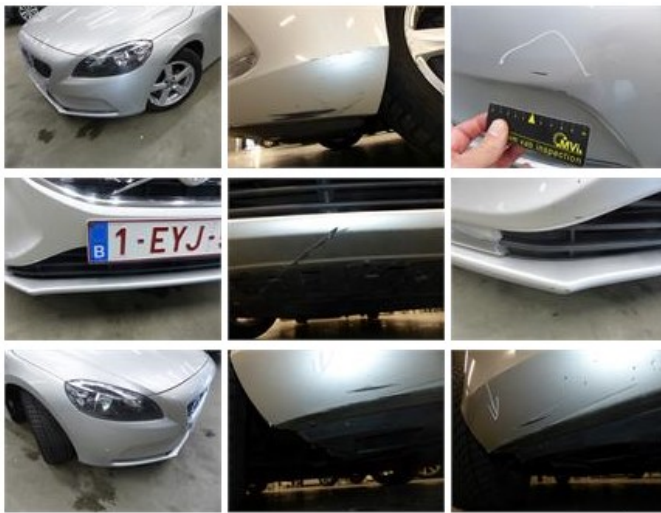
Front bumper, Scratch(es), LI - Repair and paint (complete)	<b>211,80</b>
---	---------------
