<b>VOLVO V40: 1EDX077</b>			
Vinnnumber:	<b>YV1MV8481D2018978</b>	Versionname:	<b>V40 D2 Base 115PK</b>
First Registrationdate:	<b>2/11/2012</b>	Fiscalpower:	
Expertise Mileage:	<b>118235</b>	Power Kw:	<b>84</b>
Bodytype:	<b>Break</b>	Body color:	<b>Black</b>
Gearbox:	<b>MAN 6 VIT</b>	Paint type:	<b>Metalic</b>
Transmission:	<b>Front</b>	Rims summer:	<b>Aluminium</b>
Fueltype:	<b>Diesel</b>	Oil level:	<b>OK</b>
Battery functioning:	<b>Yes</b>	Parking lot:	<b>2122</b>
Number of doors:	<b>5</b>		
Number of seats:	<b>5</b>		
Number head rests:	<b>5</b>		
Rims summer:	<b>Aluminium</b>		
Category:	<b>Passenger Car</b>		
Oil level:	<b>OK</b>

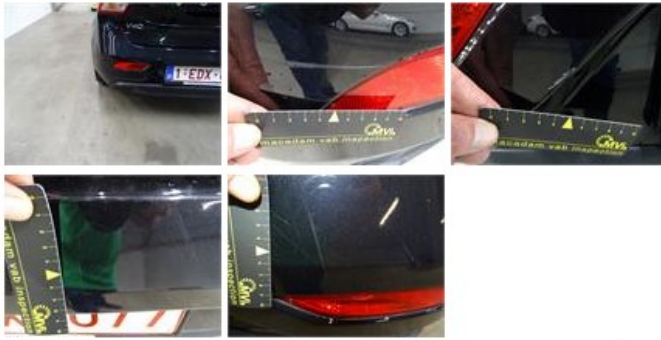
Bumper R, Scratch(es), LI - Repair and paint (complete)	211,80
---	--------
