BMW 1: 1GXXG071

| Vinnnumber: | WBA1C71030J950850 | Versionname: | 1 BER HATCH 116d 116PK |

Limited Technical Inspection

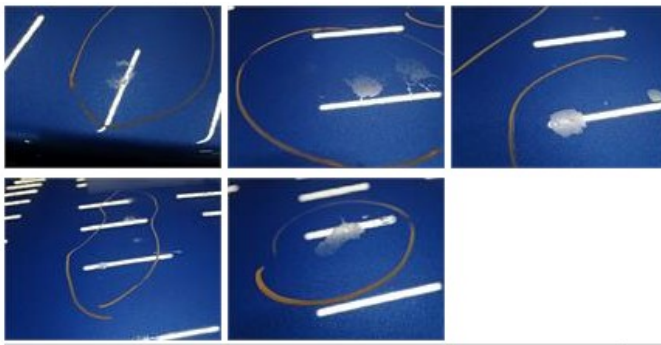
| Roof, Chemical polution, LI - Repair and paint (complete) | 481,50 |

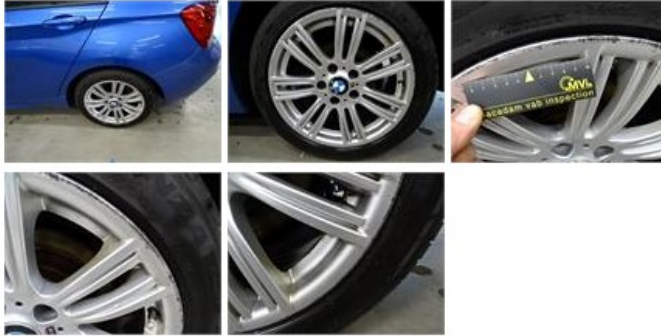
Alloy rim R L, Scratch(es), LI - Repair and paint (complete) 95,00

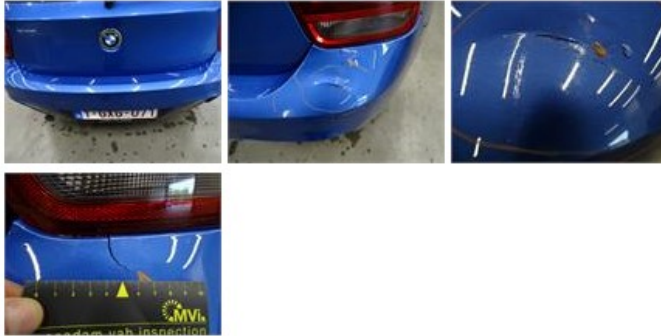
Bumper R, Bump(s) and scratch(es), Le - Replace and paint 651,00

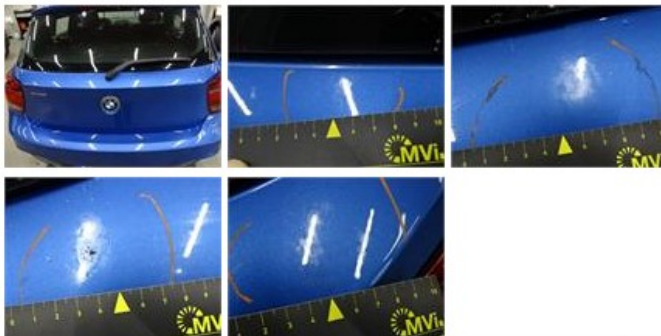
Tailgate, Chemical polution, LI - Repair and paint (complete) 301,68
