BMW 3: 1FRR625

| Vinnumber: | WBA3D91080J413053 | Versionname: | 3 BER 316d 116PK |

Limited Technical Inspection

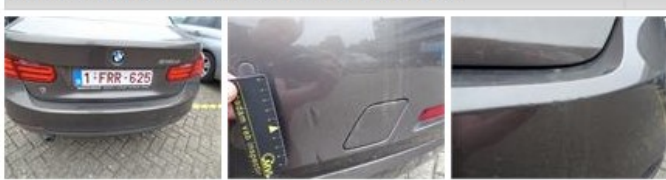
| Bumper R, Scratch(es), LI - Repair and paint (complete) | 211,80 |
